Blue Palmetto Home Inspection

Home Inspection Report

123 American Dream Street, Summerville, SC 29483
Inspection prepared for: Charles Sample
Real Estate Agent: Support - Home Inspector Pro

Date of Inspection: 2-27-2018 Time: 10:00 am
Age of Home: built in 2004 (not verified) Size: 1418 sf heated (not verified)
Weather: sunny and mild
Buyers Inspection
Sample Report

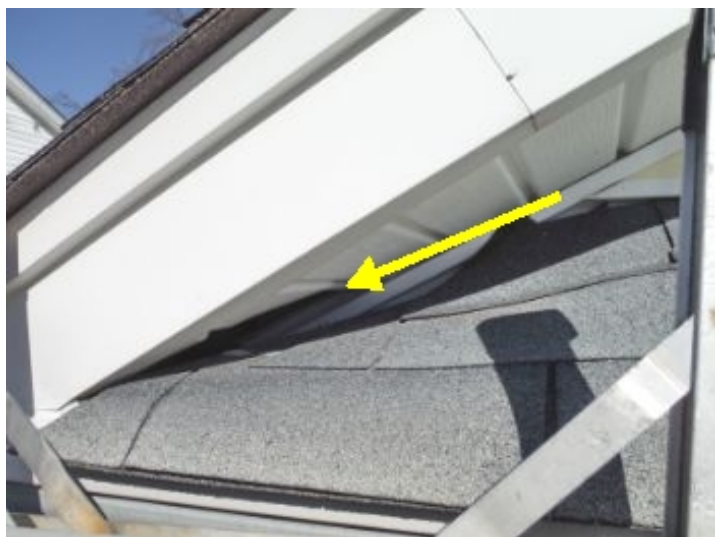
*Area pictured needs attention to prevent moisture intrusion. Also there is a hole there where vermin could enter. Recommend repair.

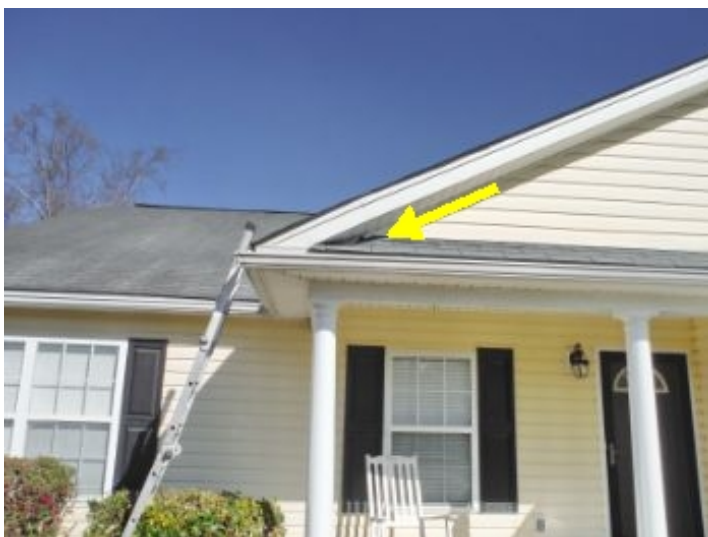
*Area pictured needs attention to prevent moisture intrusion. Also there is a hole there where vermin could enter. Recommend repair.

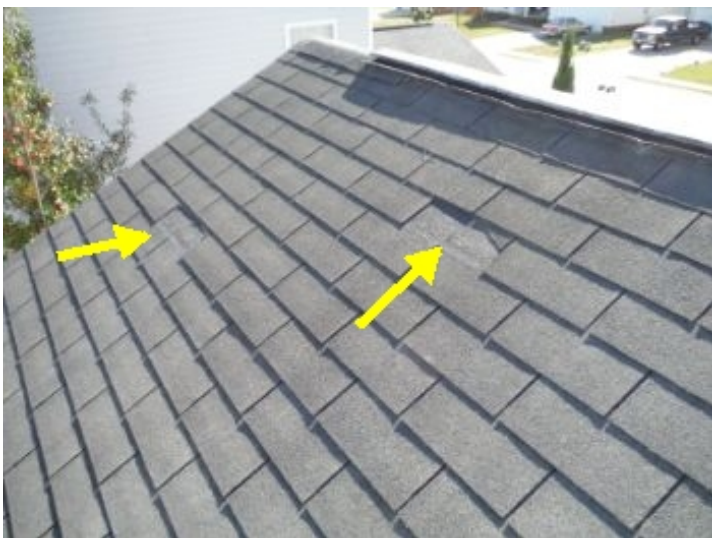
Broken or dislodged shingle at pictured location.
Repair as needed.

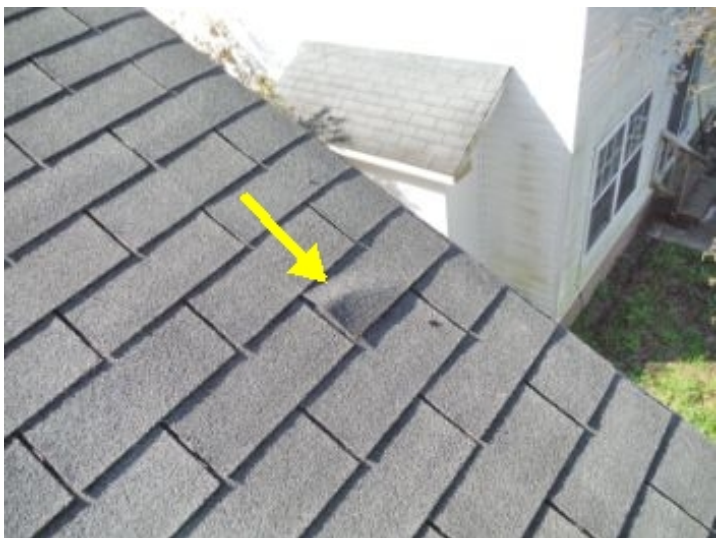
Nail pop pictured. Repair as needed to prevent
moisture intrusion.

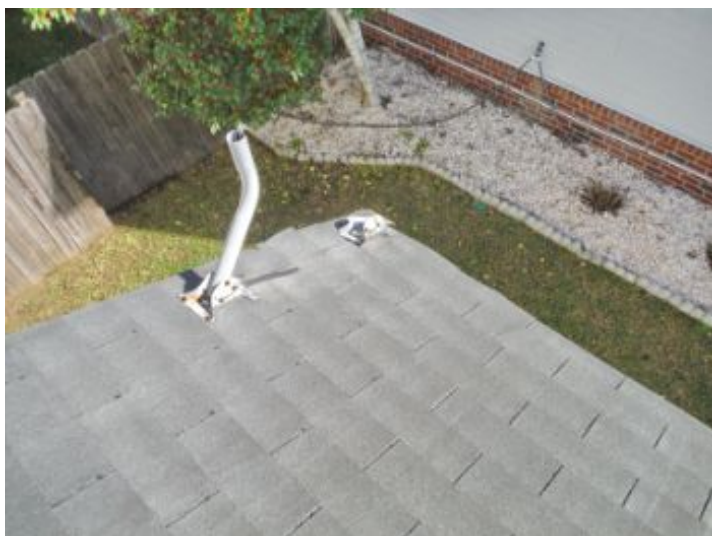
fasteners backing up- seal it up

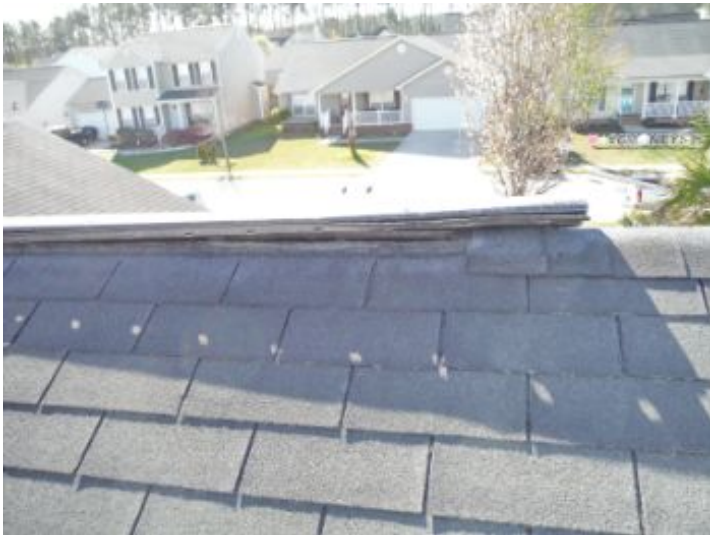
Ridge Vents (loose)- Ridge vents are coming loose in some areas enough to allow moisture or vermin into the attic area. Recommend repair as needed.

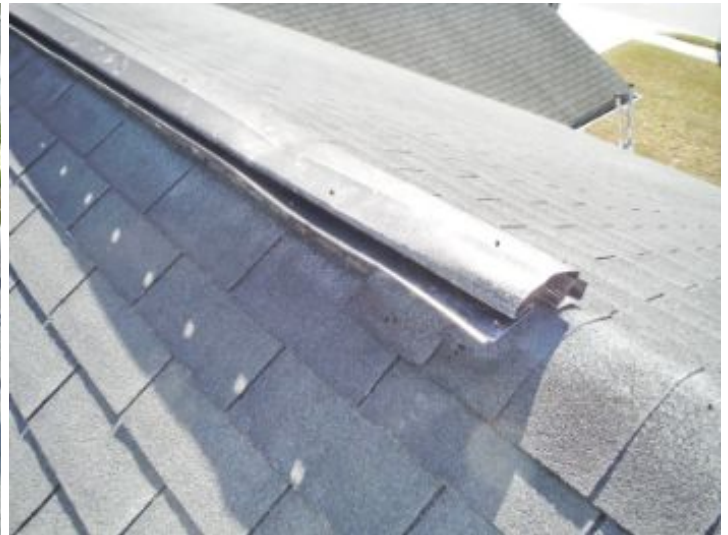
Ridge Vents (loose)- Ridge vents are coming loose in some areas enough to allow moisture or vermin into the attic area. Recommend repair as needed.

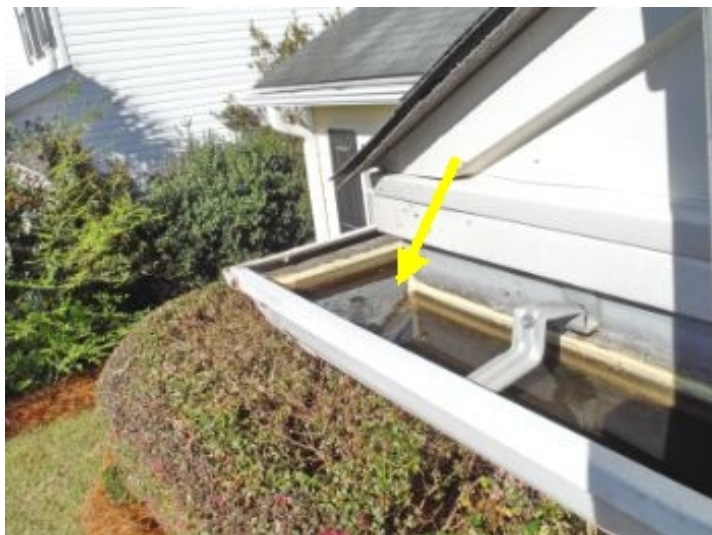
Slope (improper)- Gutter is improperly tilted away from the downspout at the location pictured. This is causing the gutter to hold water and can cause an accumulation of debris and cause stress on guttering which is not designed to hold water only to drain it. Recommend adjust as needed.

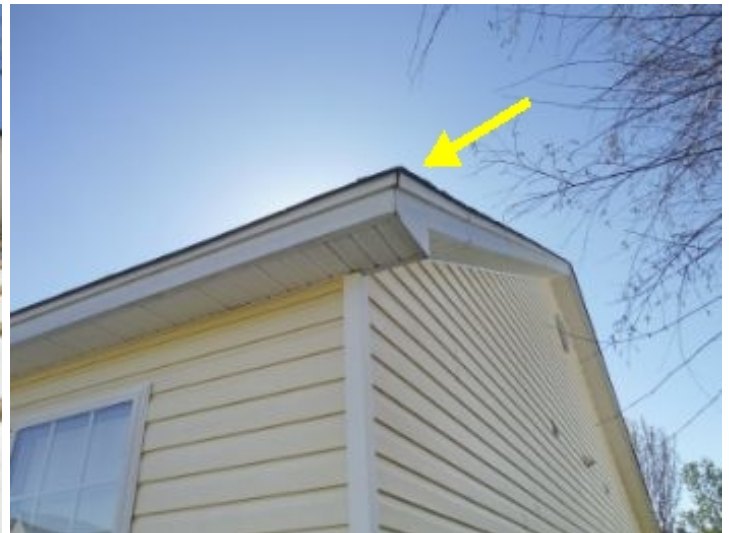
*Metal trim at corner needs to be tightened up as it has a gap.

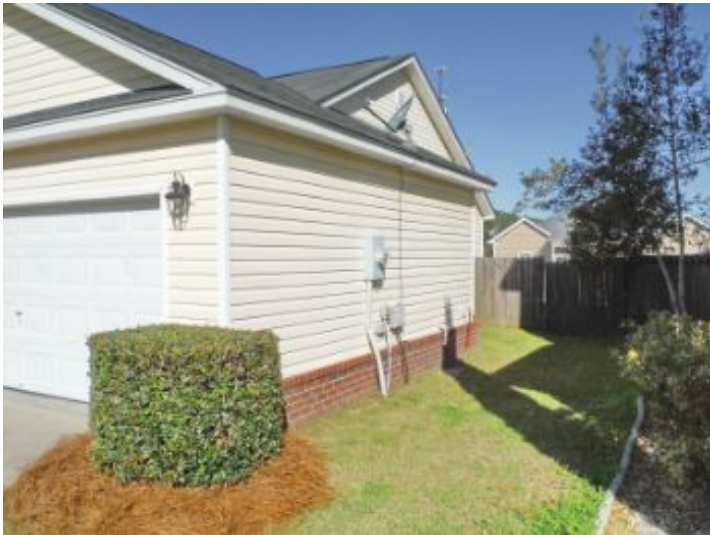
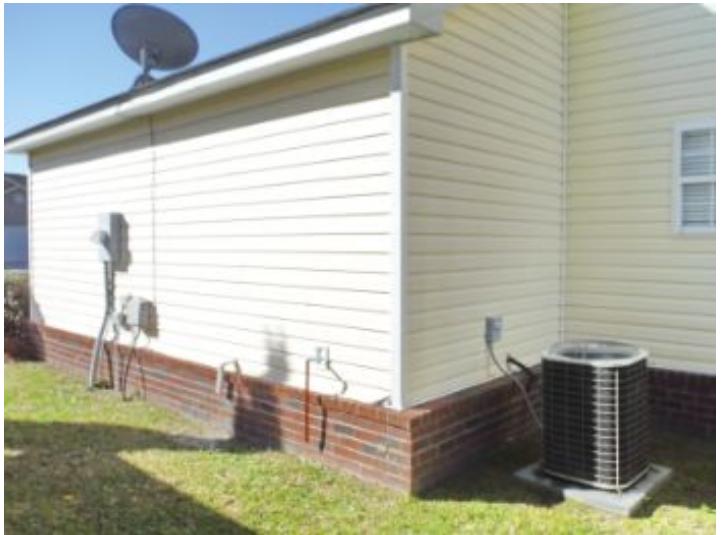
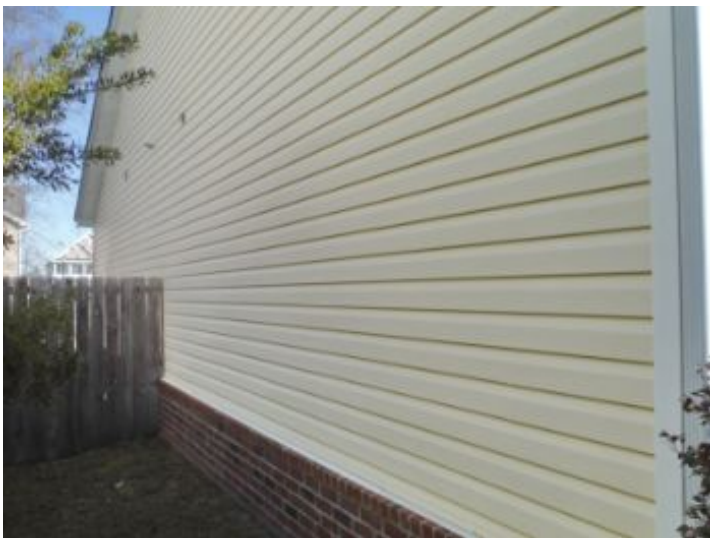
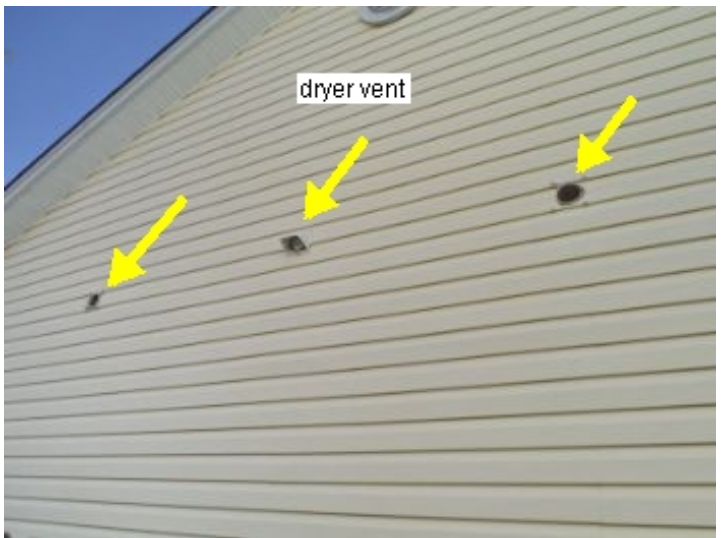
Vents (covers)- Several vent terminal/s have covers or anti-backflow dampers or covers which are in deteriorated or missing. This could allow moisture penetration or access by insects. These should be replaced.

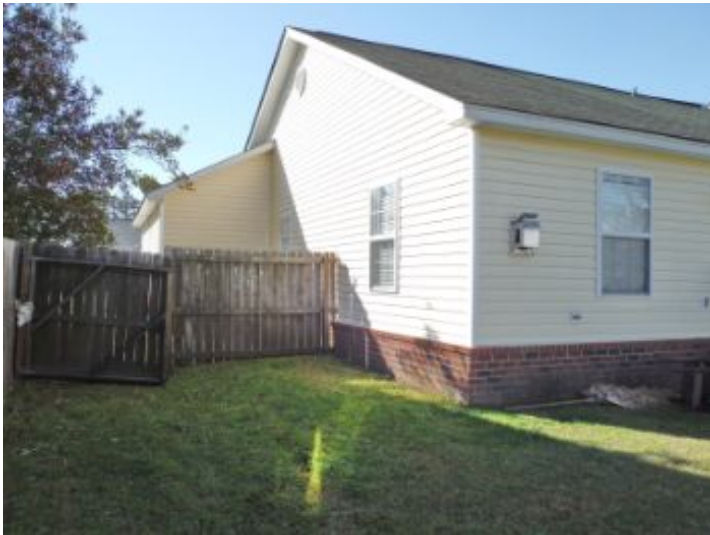
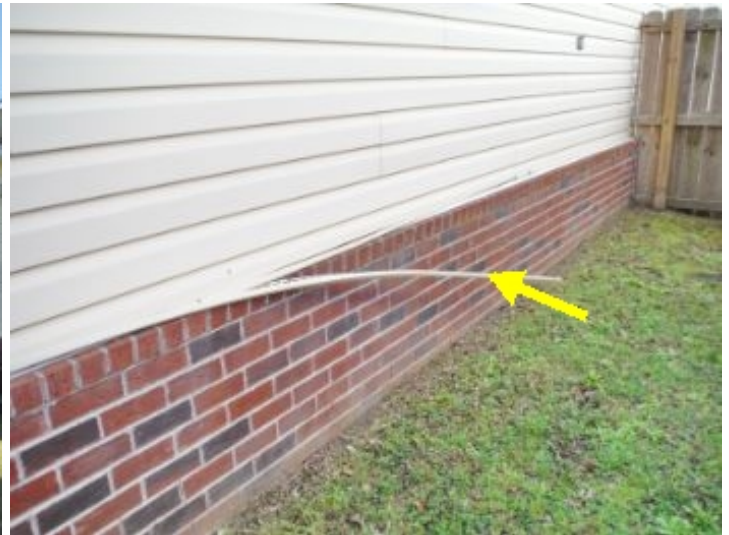
Vinyl (unlocked)- Piece of vinyl as pictured has come unlocked, is loose and needs to be properly reinstalled.

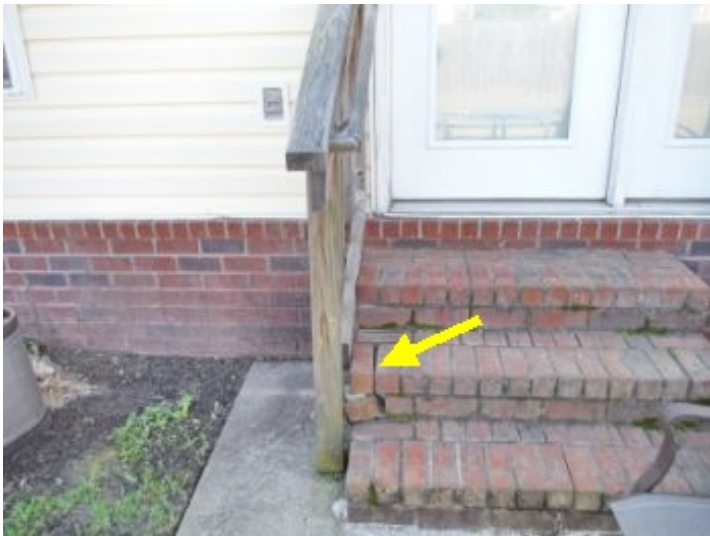
*Some bricks are dislodged at the steps. Recommend repair.

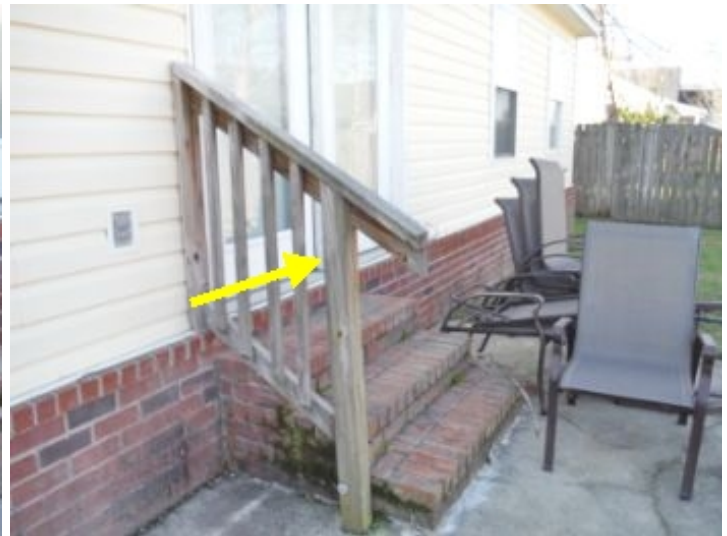
Handrails (strength)- The handrails are in disrepair and is not capable of withstanding a 200 pound force as required. This is a safety concern because the handrail could give way if someone was to lean against it. Recommend repair as needed.

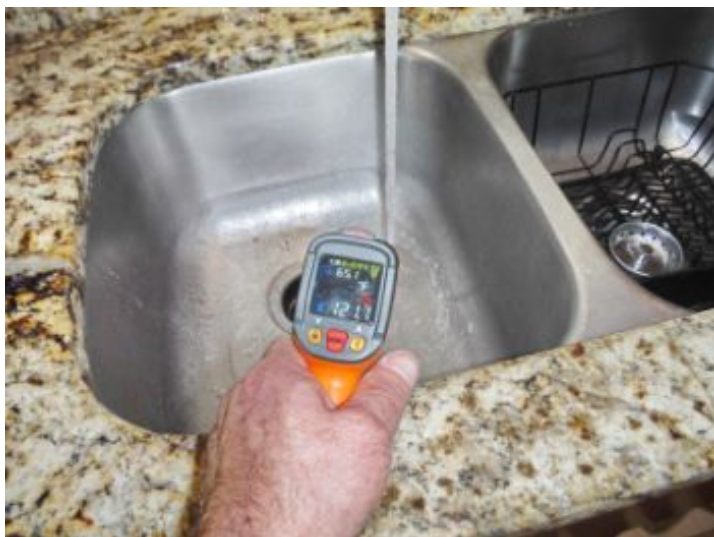
Water Temp (reading)- The water temperature at faucet is reading 120-125 degrees which is considered hot.

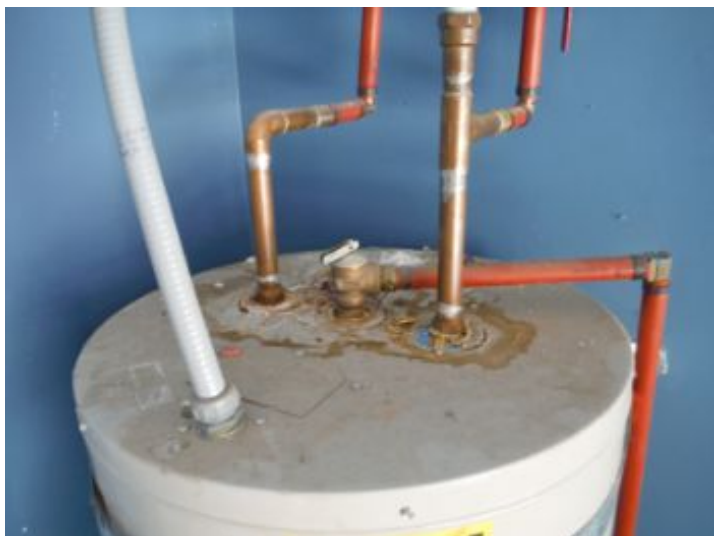
Severe Corrosion at pictured area on the water heater. Areas felt wet briefly when I rubbed it. Probable leak area. Corrosion even if minor has the potential for leakage. Recommend evaluate/repair by a qualified plumber.

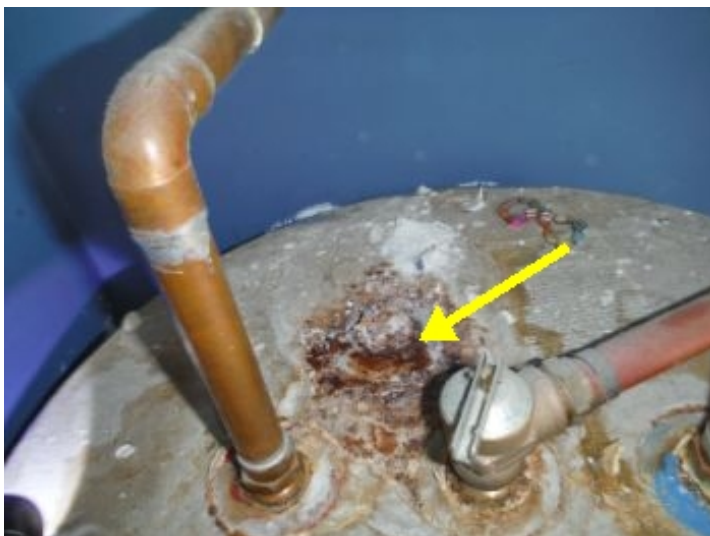
Severe Corrosion at pictured area on the water heater. Areas felt wet briefly when I rubbed it. Probable leak area. Corrosion even if minor has the potential for leakage. Recommend evaluate/repair by a qualified plumber.

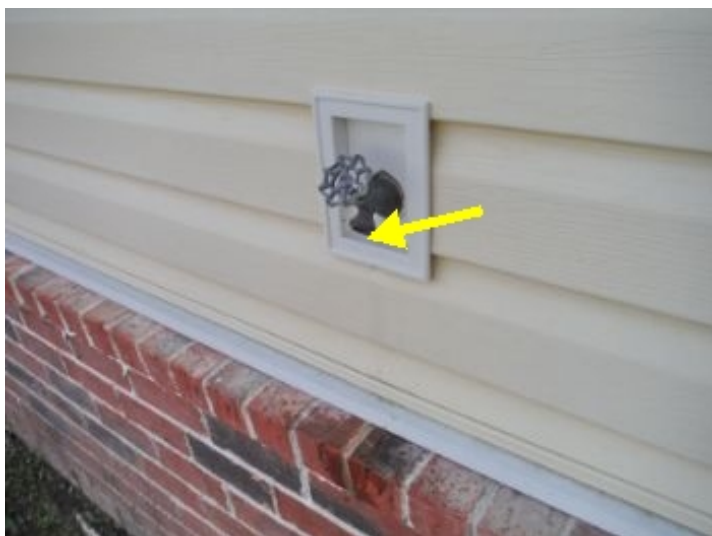
- *Absent (all)- Noted not present on hose bibs.(anti backflow devices) Recommend improve. Explanation- An anti- backflow device on a hose bib is a device that only allows water to flow one way in order to protect the water supply from possible contamination. They usually screw onto the hose bib and are inexpensive to replace if needed. More modern regulations require them.
- *Absent (all)- Noted not present on hose bibs.(anti backflow devices) Recommend improve. Explanation- An anti- backflow device on a hose bib is a device that only allows water to flow one way in order to protect the water supply from possible contamination. They usually screw onto the hose bib and are inexpensive to replace if needed. More modern regulations require them.

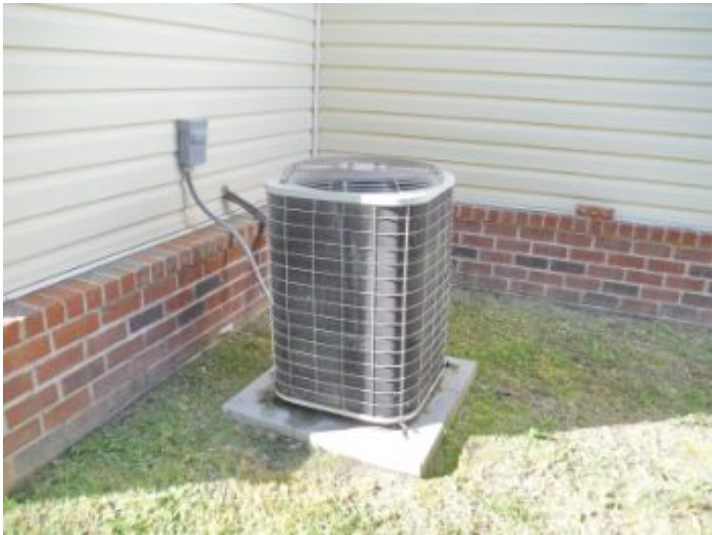
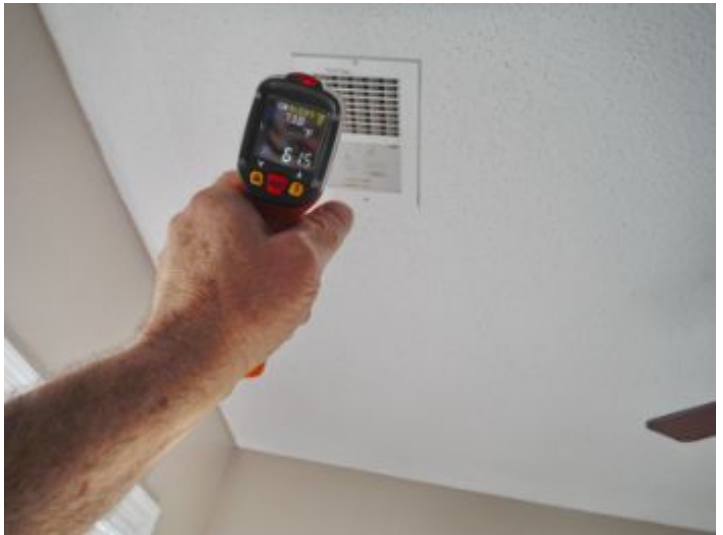
*Evaluate- The call for AC was marginal at best. It barely put out cool air on the third try. It may need service. Have a qualified HVAC technician evaluate and repair.

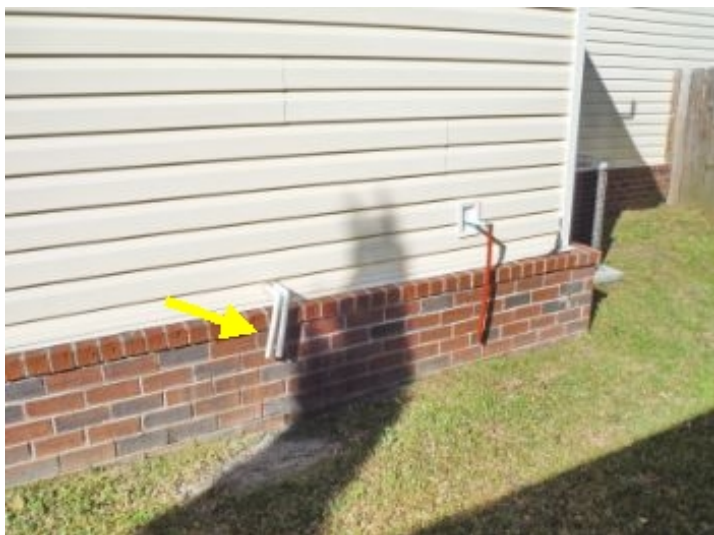
Condensate drain line exit location.

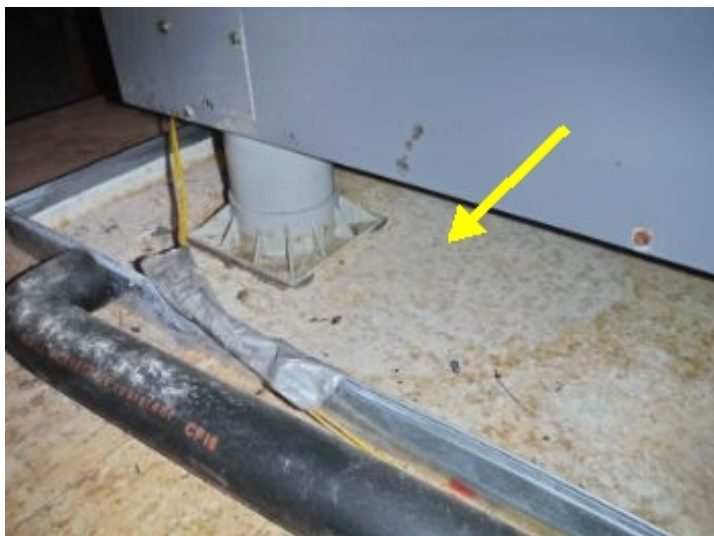
*There was rust or efflorescence in the overflow drain pan. Normally the overflow pan should be empty and the presence of rust and efflorescence indicates that the primary pan drain was blocked at some point in time and overflowing into the secondary pan. Efflorescence is a type of white powdery salt left behind when water evaporates repeatedly. Recommend evaluation/improvements by a qualified HVAC contractor to make sure this does not happen again or regular maintenance, (keep the trap clean).

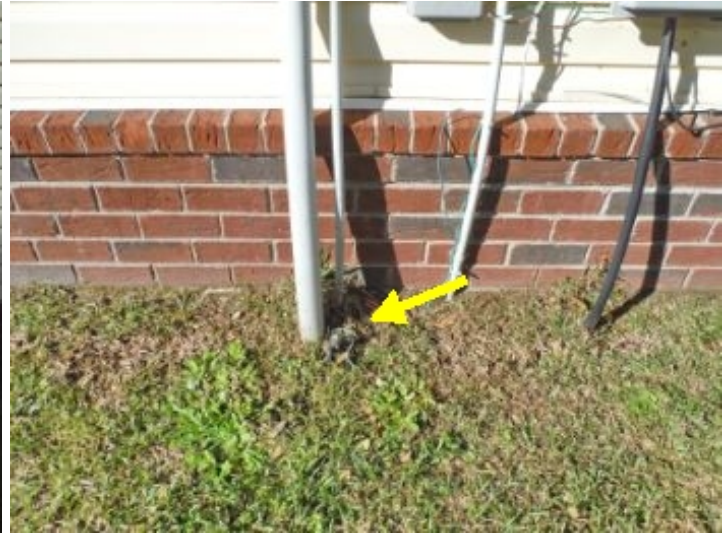
Ground Rod (above grade)- The ground rod is sticking up a little. The ground rod should be fully driven flush, below grade or protected. Grounding conductors should be protected where subject to damage. This is to protect it from accidental damage from lawn mowers, weed eaters etc.

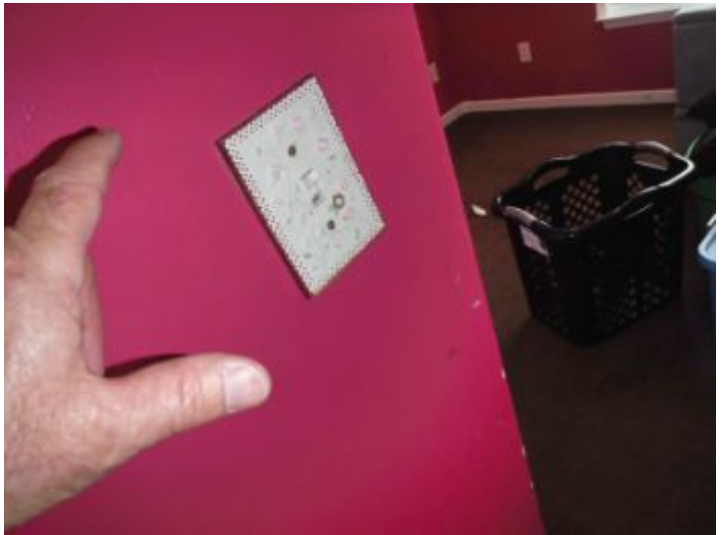
*Switch pictured is poorly mounted. Outlets and switches are required to be securely mounted in the box. Recommend repair.

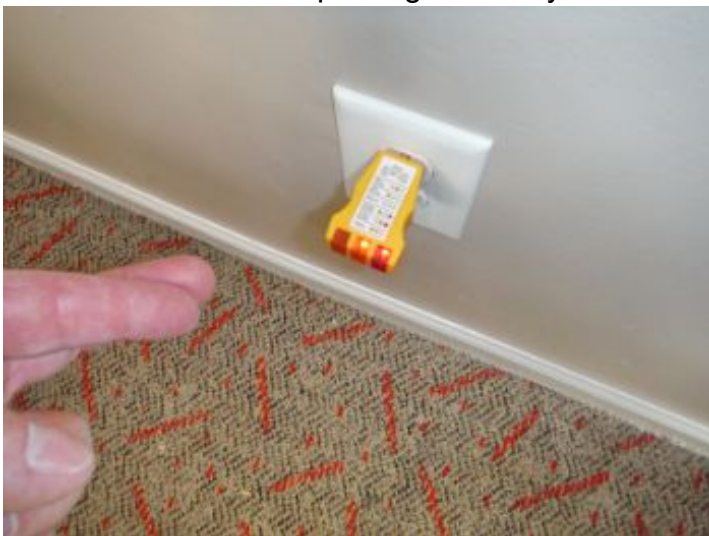
Outlets- All electrical outlet/s in the front bedroom showed an - hot, neutral reversed (reversed polarity) condition. Have a qualified electrician repair.

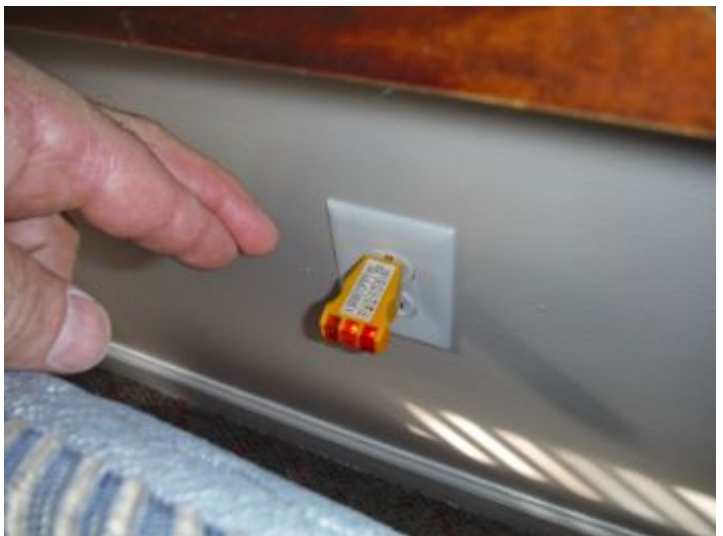
Outlets- All electrical outlet/s in the front bedroom showed an - hot, neutral reversed (reversed polarity) condition. Have a qualified electrician repair.

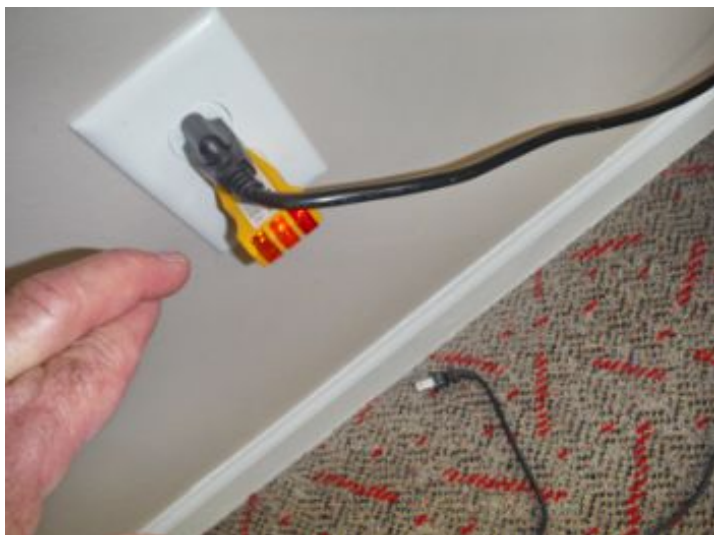
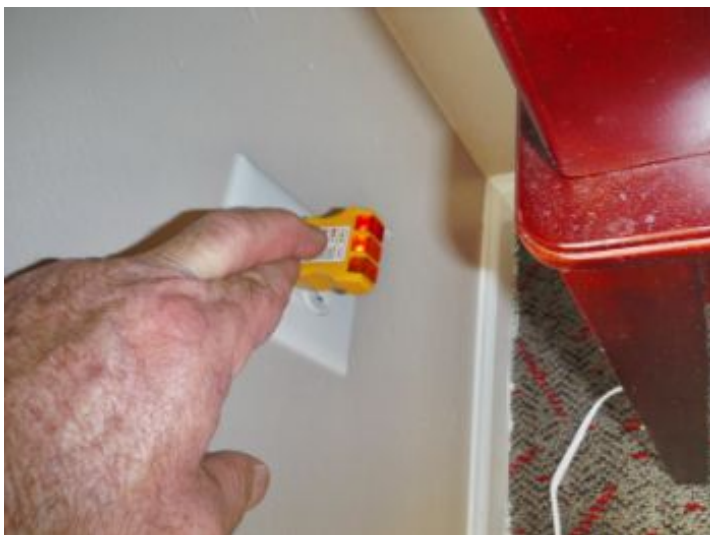
Outlets- All electrical outlet/s in the front bedroom showed an - hot, neutral reversed (reversed polarity) condition. Have a qualified electrician repair.

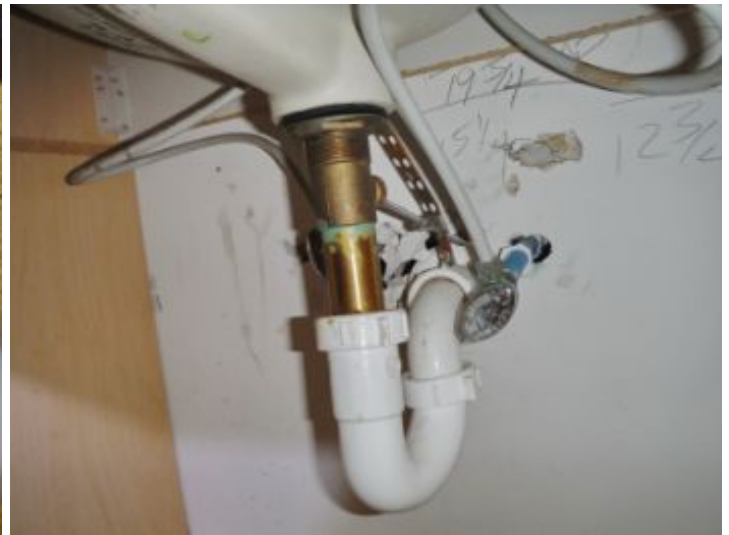
Stopper (missing)- Stopper is missing/inoperable.
Repair as needed.

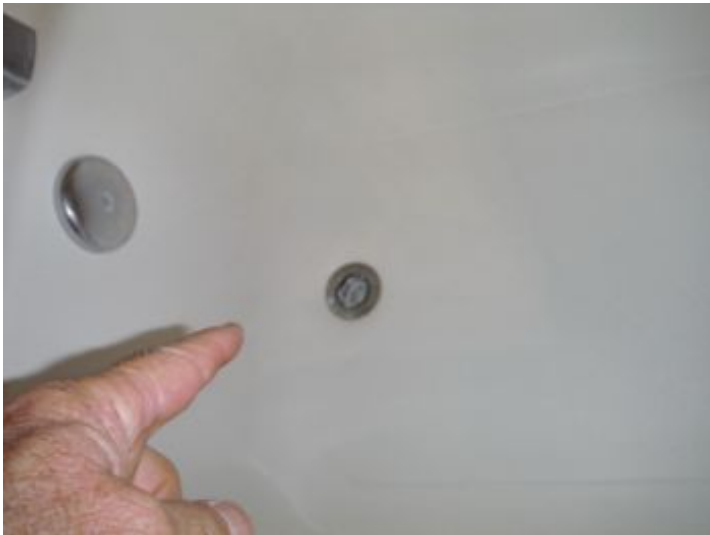
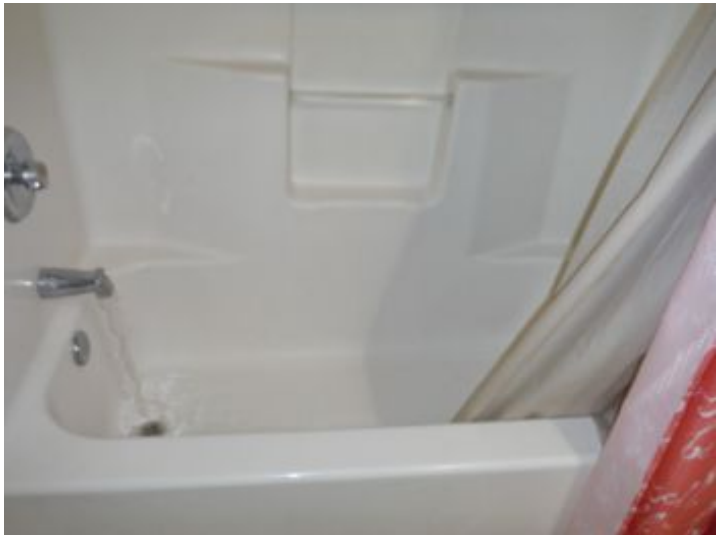
Stopper (missing)- Stopper is missing or inoperable. Repair as needed.

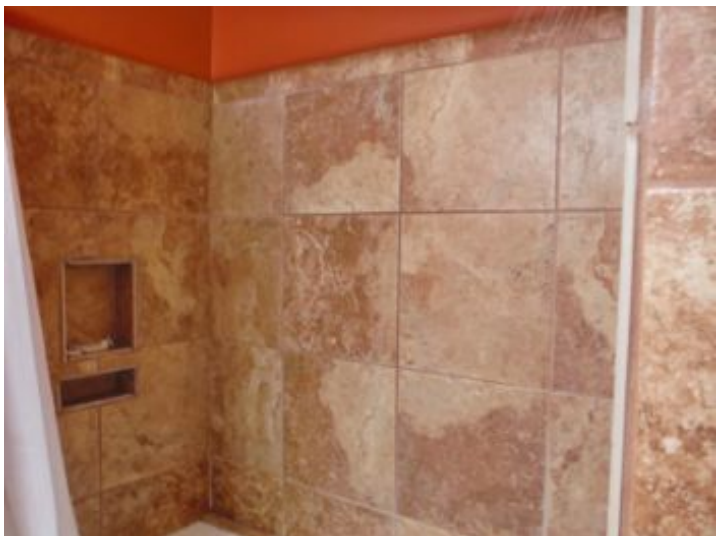
*I believe that the way the tile is laid it can allow water to drain behind the tub. Some evidence of this was observed. Loose tiles observed. Recommend contact an experienced tub, shower installer and tile expert to solve this issue.

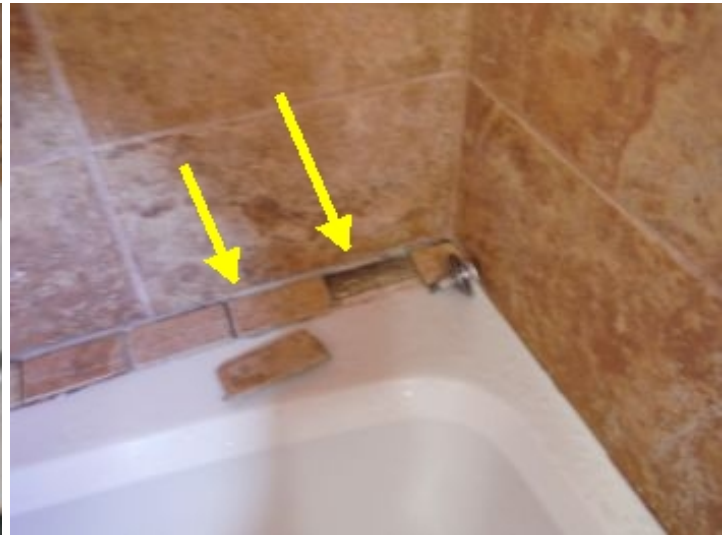
*I believe that the way the tile is laid it can allow water to drain behind the tub. Some evidence of this was observed. Loose tiles observed. Recommend contact an experienced tub, shower installer and tile expert to solve this issue.

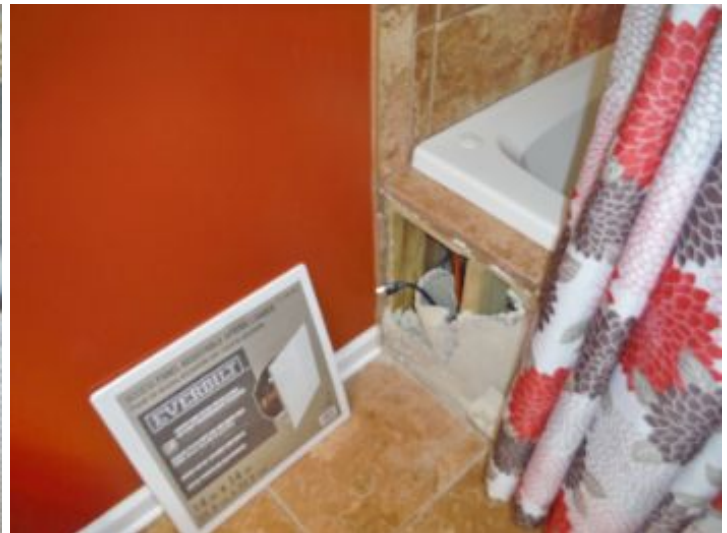
*The installation of the access panel for the tub motor was not complete. Broken tile observed. Recommend have the jetted tub and its components installed before closing.

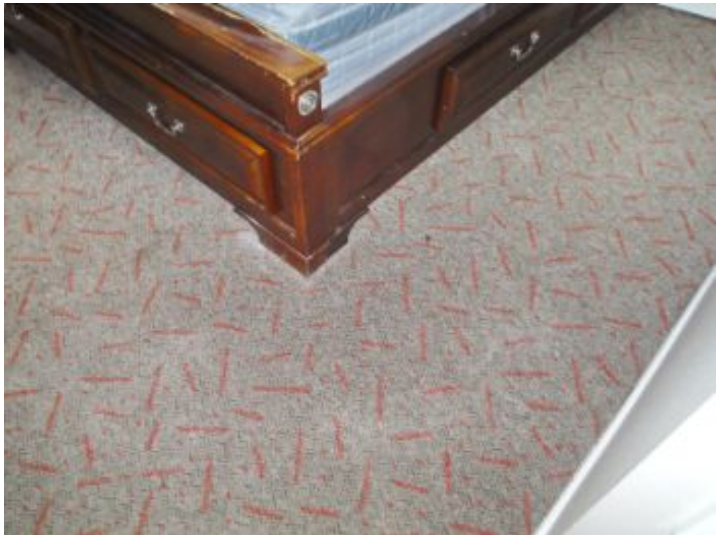
*Noted moisture damaged flooring in front of master bathroom door. Recommend repair.

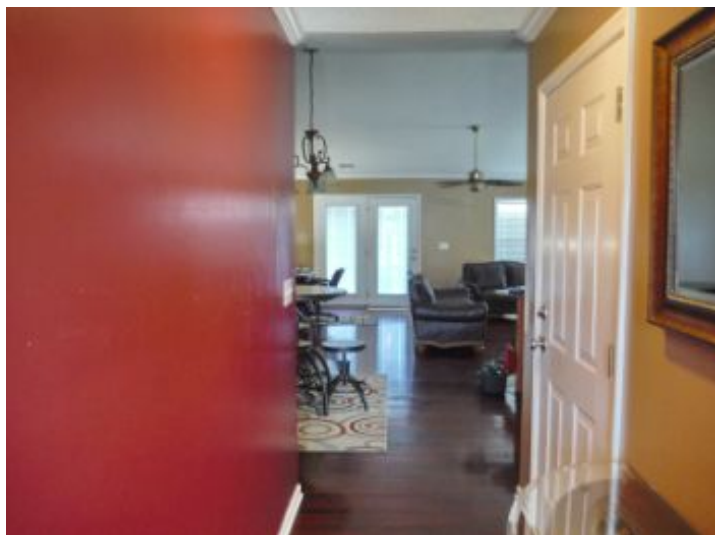
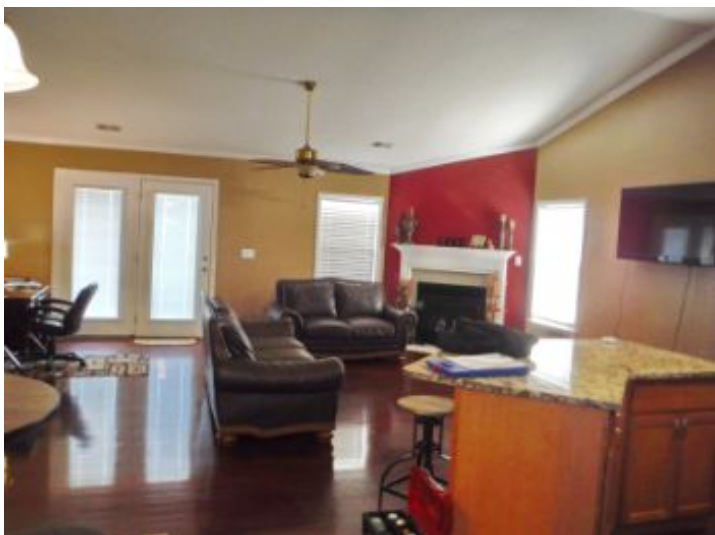
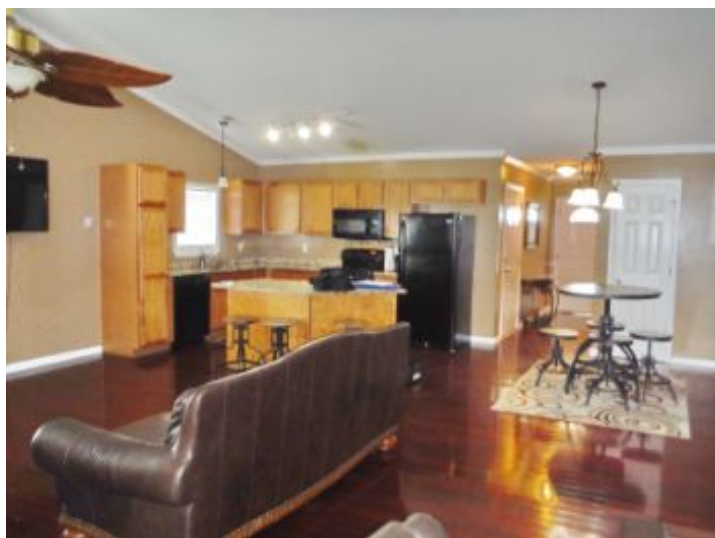
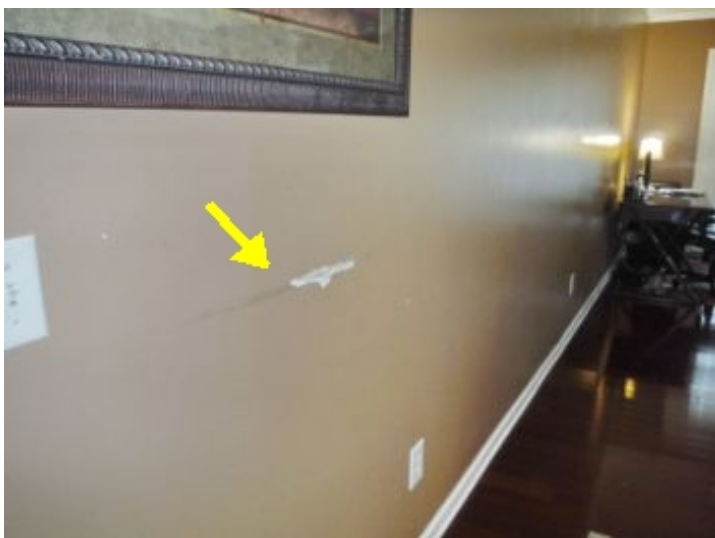
Noted several holes in the wall and some incomplete patch jobs. Some are pictured. Recommend review all with seller before closing and have them repaired. Note(It is beyond the scope of a home inspection to document every ding and picture hanging hole.)

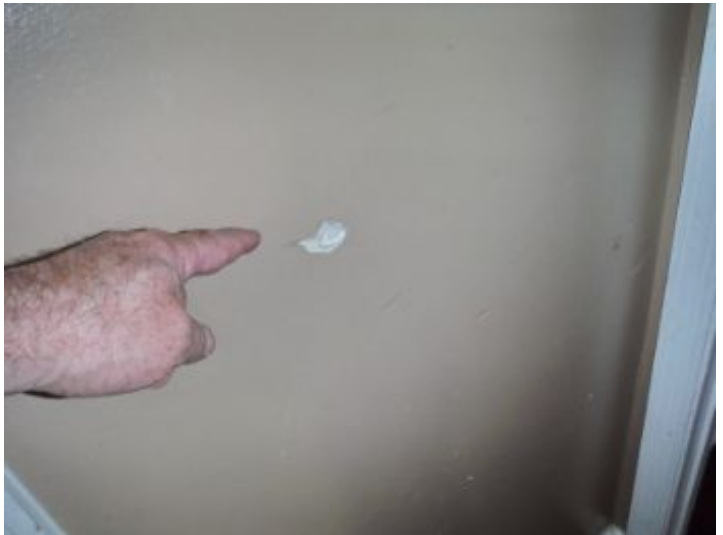
Noted several holes in the wall and some incomplete patch jobs. Some are pictured. Recommend review all with seller before closing and have them repaired. Note(It is beyond the scope of a home inspection to document every ding and picture hanging hole.)

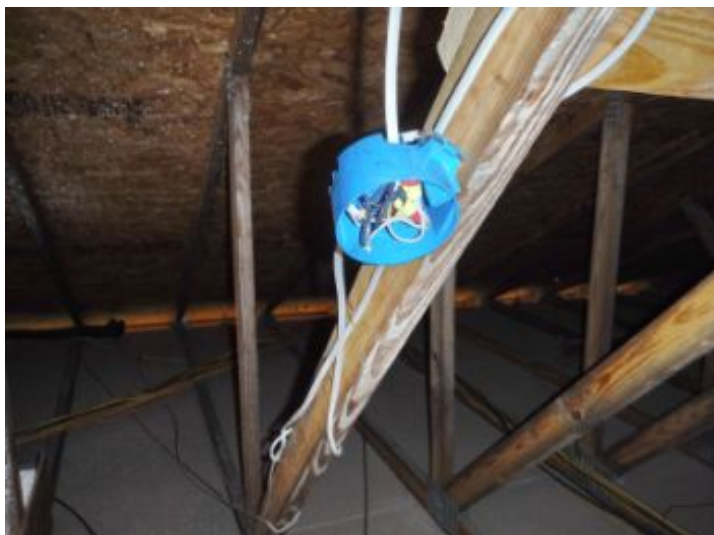
J Box Covers- Noted A junction boxes without a suitable cover, which is a safety concern. As pictured. Recommend installing proper covers, as needed, for safety. In addition boxes need to be properly attached to framing as required. Wires properly stapled to framing within 8" of box. If metal boxes are used then they are required to be bonded (grounded) with strain relief clamps in place. Recommend repair all as needed.
