Blue Palmetto Home Inspection

Property Inspection Report

1 Brand New Street, New Exciting Town SC
Inspection prepared for: Jim Sample
Inspection Date: 4/5/2012 Time: 10:00 am
Age: new (pre drywall) Size: 1700 + - (+garage,porches)
Weather: hot! mostly sunny
This is just a Sample Report
Current Address
1 Old House Lane, Old Town SC

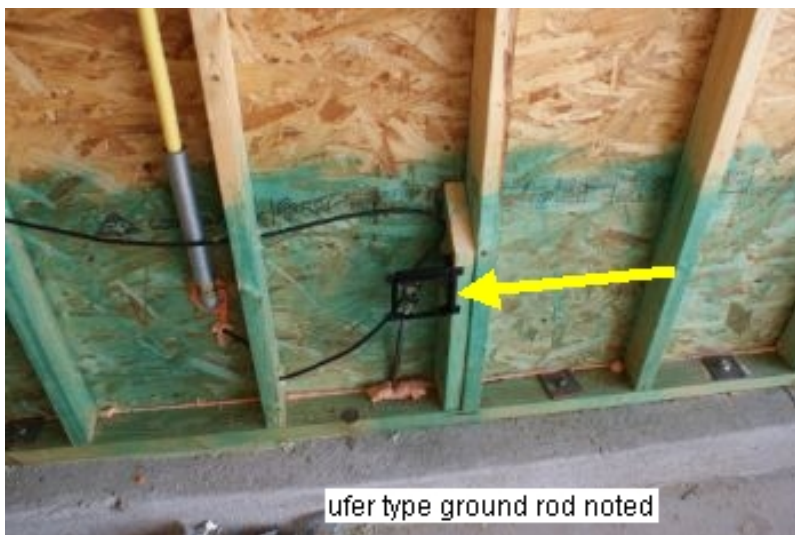
ufer type ground rod noted

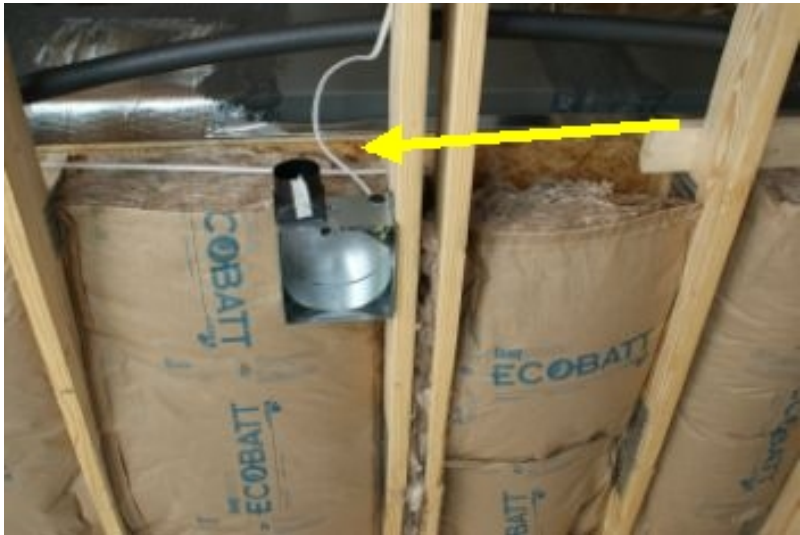
6. Bath Vent Ducts

- This bathroom fan was missing the duct.

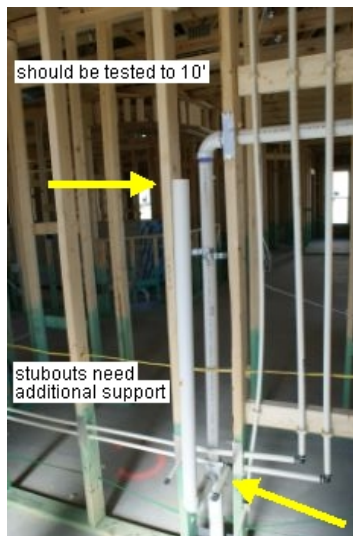
2. Visible Waste Piping

- stubouts need additional support
- The cap was missing on this drain pipe which means the system was tested only to about 5'. Standards require 10' for 15 minutes.

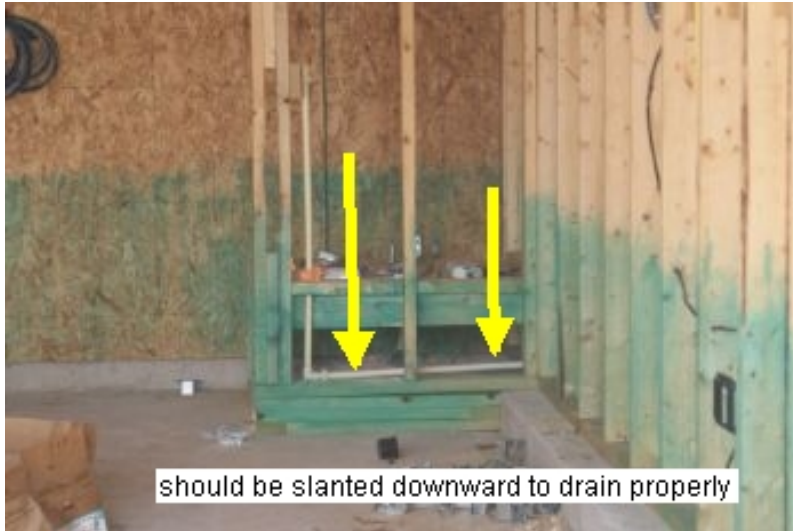
5. Overflow Condition

- The future tpr drain line appears to be slanted upwards. This line should be installed so as to flow by gravity.

should be slanted downward to drain properly

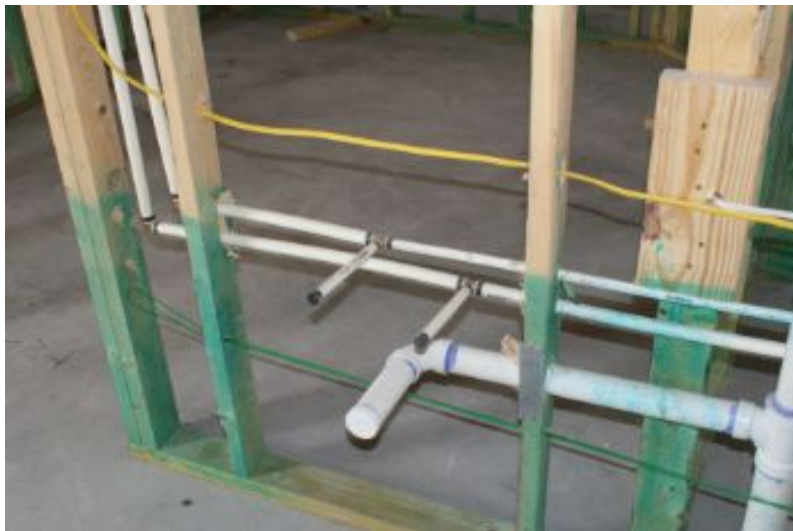
6. Guards, Support, leaks

- We feel that the stub outs under some of the sinks in the bathrooms could have been supported better but otherwise a good job. I suggest correction by the plumber before covering with wallboard

We feel that the stub outs under some of the sinks in the bathrooms could have been supported better but otherwise a good job. I suggest review by the plumber before covering with wallboard

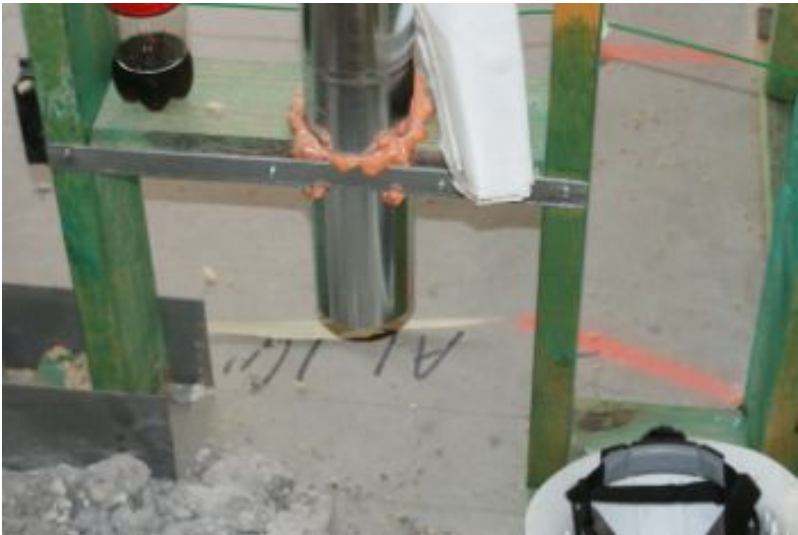
7. washer & dryer observations

- Dryer vent should eventually be fitted with an elbow behind the dryer for proper connection to the metal duct should that area be sheet rocked.
- There were workmen in the laundry room removing part of the floor in order to install a drain. As a result this section could not be inspected at this time.

Dryer vent should eventually be fitted with an elbow behind the dryer for proper connection to the metal duct should that area be sheet rocked.

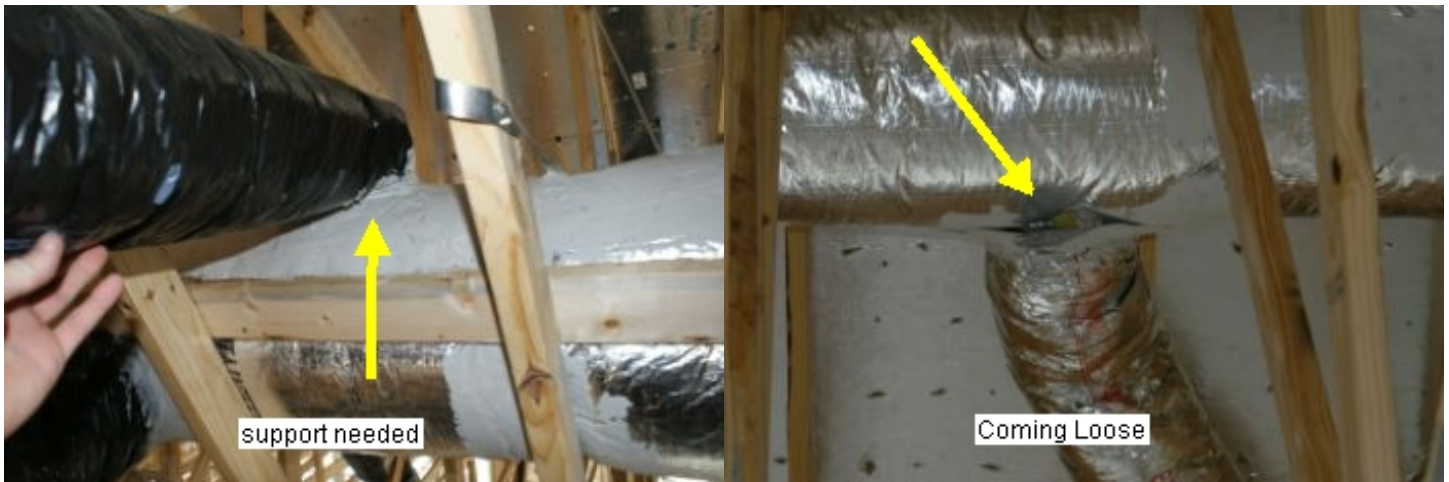
9. duct observations

- This duct needs additional support to prevent reduced air flow in the area served by the duct.
- Observed mastic coming loose in two locations over living room.

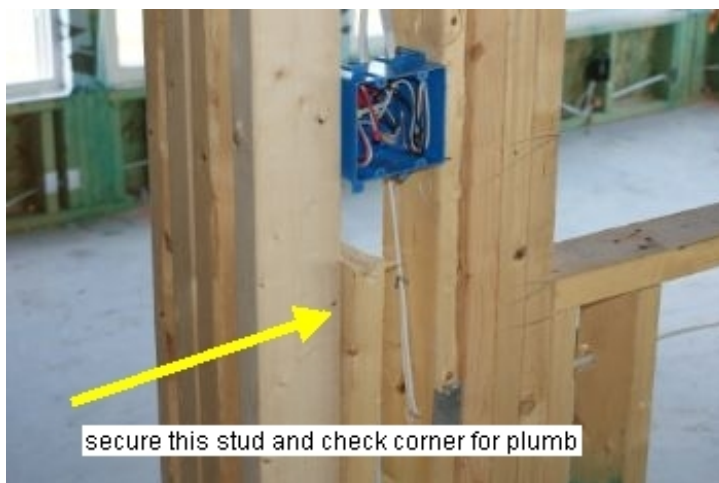
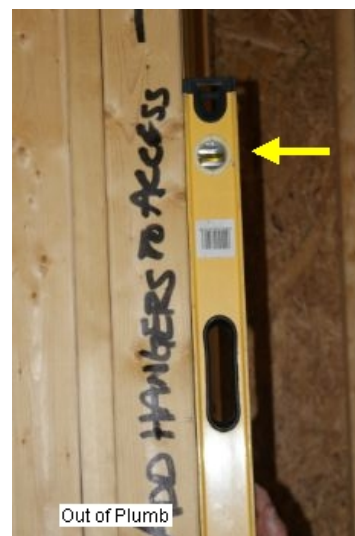
2. wall framing observations

- secure this stud and check corner for plumb
- This wall near the master bath is slightly out of plumb.

secure this stud and check corner for plumb

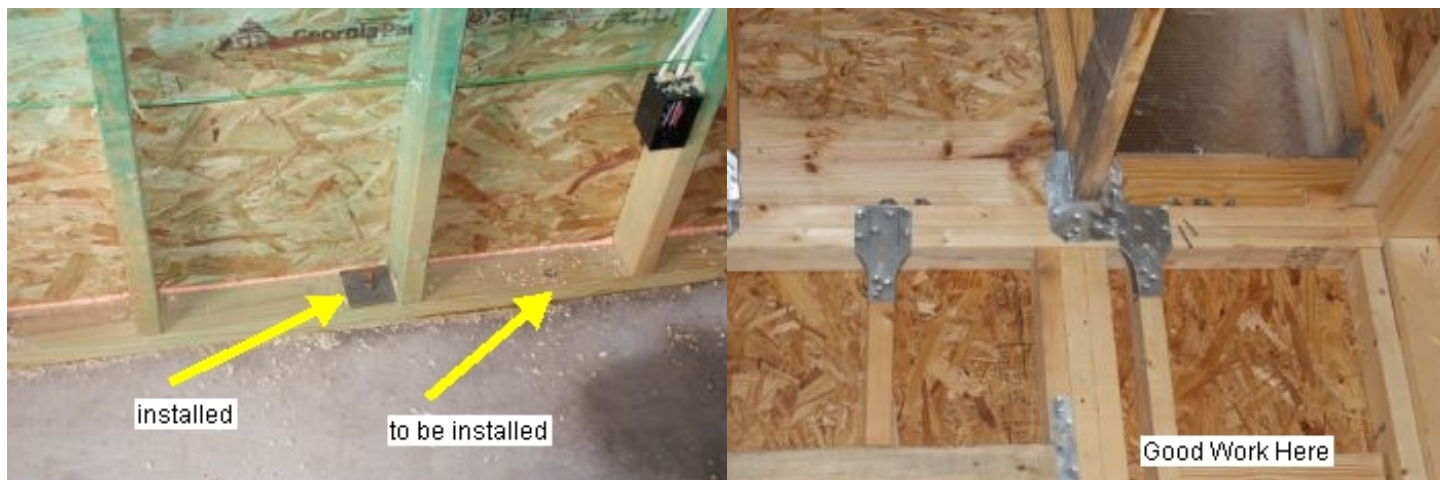
3. Strapping and Anchoring

- incomplete at time of inspection

incomplete at time of inspection

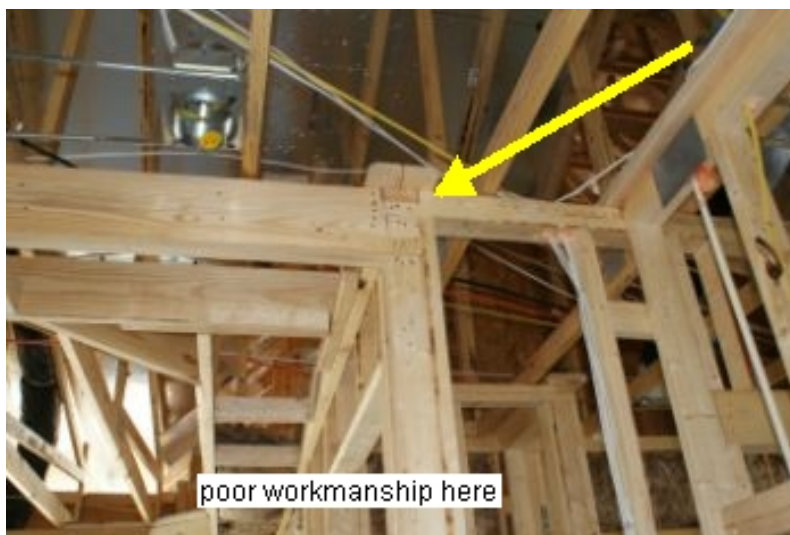
6. structural deficiencies

Page 16 Item: 6	structural deficiencies	• Since the plans and truss drawings were unavailable it is unclear if this beam is meant to be load bearing. If it is then it appears to be undersized, under nailed and the end notch appears to exceed D/4. Also it appears to be cut almost completely through at the notch area. I recommend review and repair by the appropriate professionals.
Roof Framing		
Page 19 Item: 1	Roofs & Truss Framing	• The bent gangnail could cause the structural failure of this truss. Repair should be made per truss engineer recommendations.
Page 20 Item: 2	Support,Bracing	<ul style="list-style-type: none"> • Truss bottom chord was improperly braced. There should be 2x4 lateral bracing on top of the bottom chord of the trusses at less than 10' intervals running perpendicular to the trusses as per standard building practice. • Garage trusses need a horizontal brace here. • Always defer to the engineered truss drawings for exact placement. • I suggest careful review of the truss documentation which was unavailable for the inspection to see which type of support and connectors are needed here. Typically you would see a girder truss and hangers for the trusses in this area.

- Since the plans and truss drawings were unavailable it is unclear if this beam is meant to be load bearing. If it is then it appears to be undersized, under nailed and the end notch appears to exceed D/4. Also it appears to be cut almost completely through at the notch area. I recommend review and repair by the appropriate professionals.

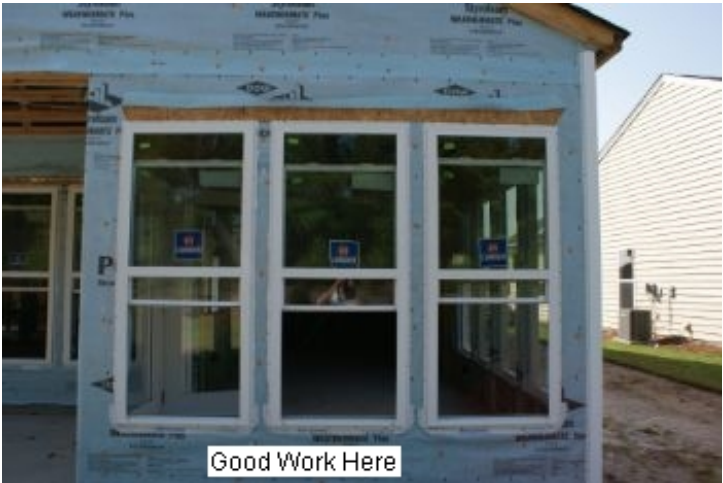
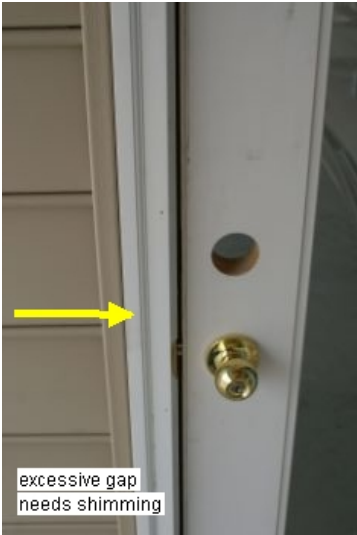
8. Window and Doors Observations

Materials: Single Hung double paned vinyl windows noted. • dp 50 noted
Materials: Inspected
Observations:
• Out swing door on back porch needs minor adjustment.

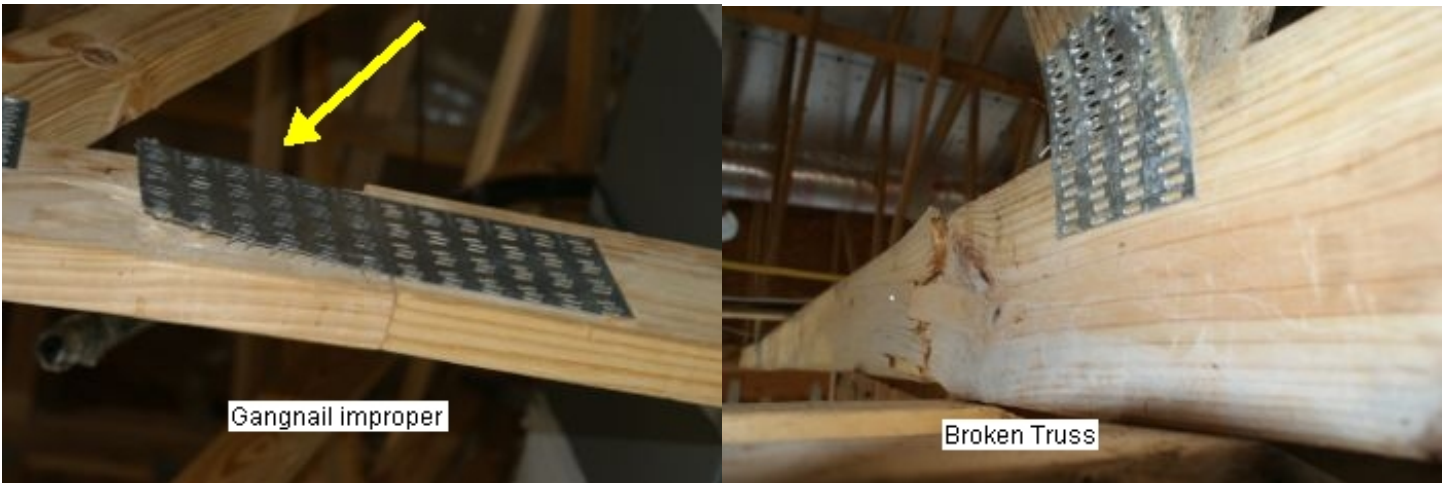
1. Roofs & Truss Framing

- The bent gangnail could cause the structural failure of this truss. Repair should be made per truss engineer recommendations.

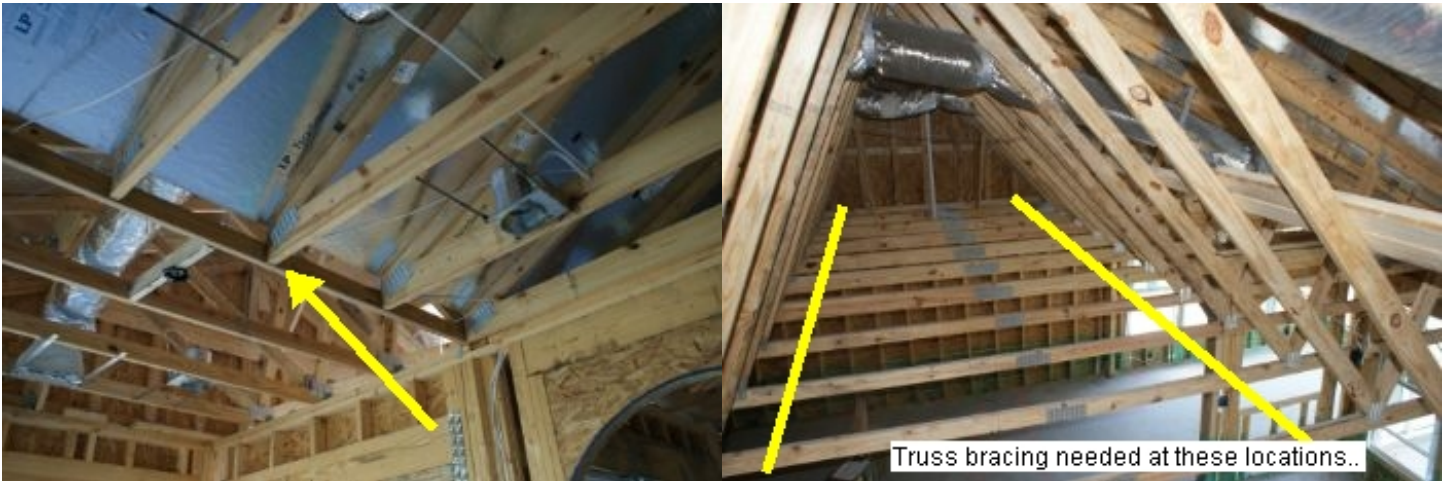
2. Support,Bracing

- There is an area over the front door where several trusses look out of plumb. While it is probably within acceptable tolerances; it is an indication of poor quality workmanship in that area.
- Truss bottom chord was improperly braced. There should be 2x4 lateral bracing on top of the bottom chord of the trusses at less than 10' intervals running perpendicular to the trusses as per standard building practice.
- Garage trusses need a horizontal brace here.
- Always defer to the engineered truss drawings for exact placement.
- I suggest careful review of the truss documentation which was unavailable for the inspection to see which type of support and connectors are needed here. Typically you would see a girder truss and hangers for the trusses in this area.

I suggest careful review of the truss documentation which was unavailable for the inspection to see which type of support and connectors are needed here. Typically you would see a girder truss and hangers for the trusses in this area.

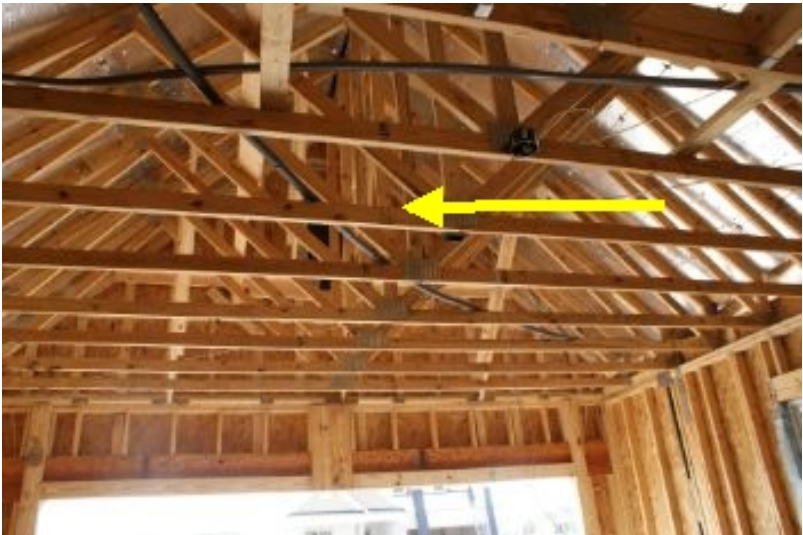
Truss bottom chord was improperly braced. There should be 2x4 lateral bracing on top of the bottom chord of the trusses at less than 10' intervals running perpendicular to the trusses as per standard building practice.

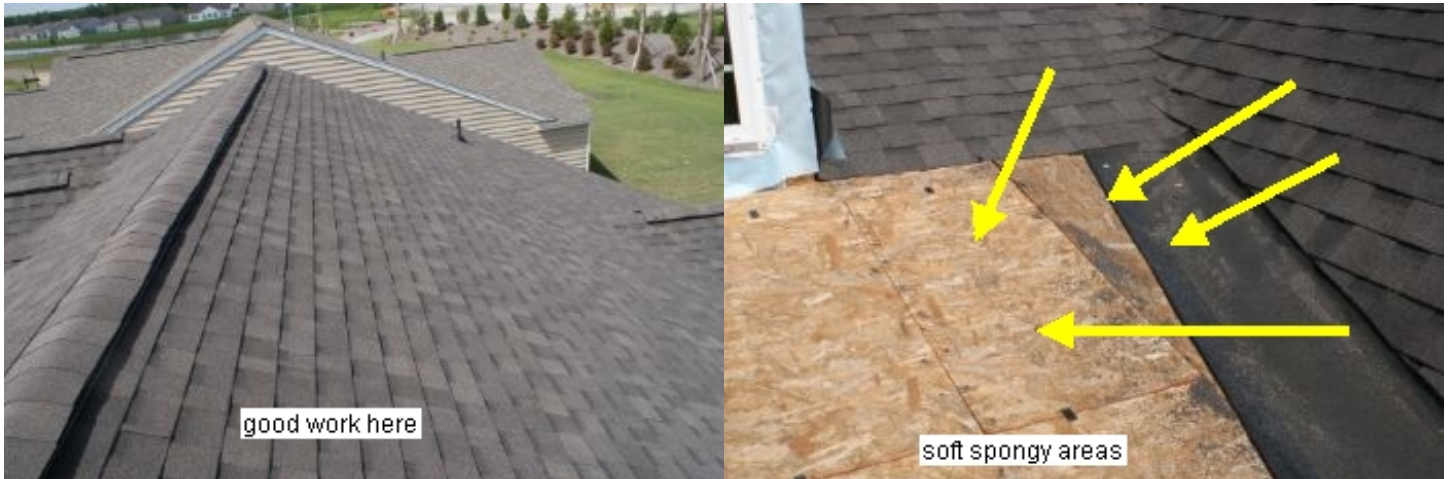
3. Covering Observations

- The roof covering is not complete at this time.
- The roof covering is not complete at this time.
- The area in the valley was soft and spongy. I recommend installing support blocks from underneath to reinforce this area.

The area in the valley was soft and spongy. I recommend installing support blocks from underneath to reinforce this area.

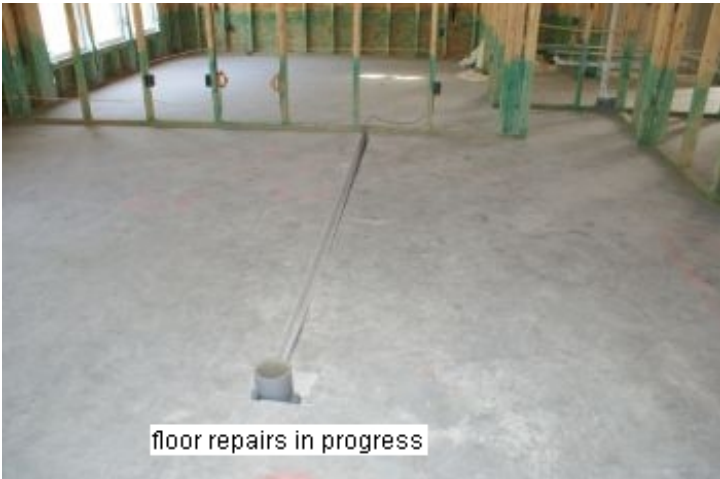
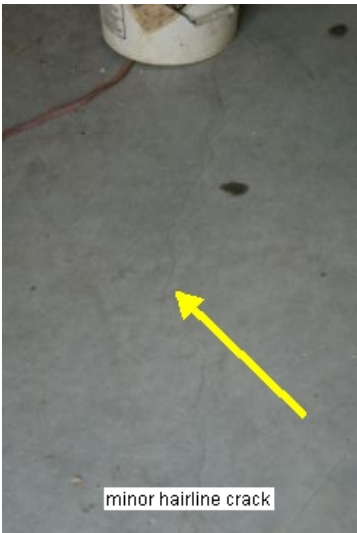
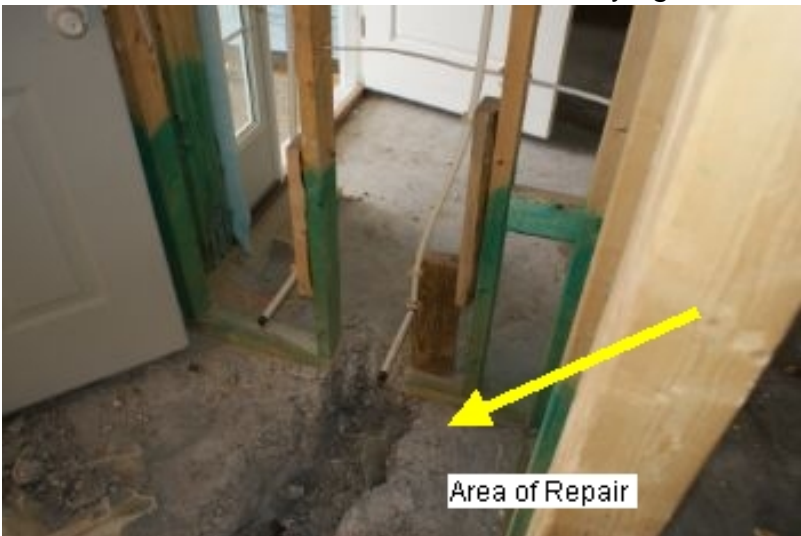
1. Floor Type Observations

- There were some minor hair line cracks noted in some areas. Extra care should be taken when laying tile in these areas.
- Workers were busy removing a section of the concrete floor in the laundry room in order to install a drain. Jackhammering in this area may have caused a hairline crack in the concrete near that area. It is not unusual for workmen to occasionally have to relocate a pipe or electrical line in that manner however the repairs to the floor need to be done carefully. I recommend using a qualified contractor that will closely supervise the repairs for quality control.

There were some minor hair line cracks noted in some areas. Extra care should be taken when laying tile in these areas.

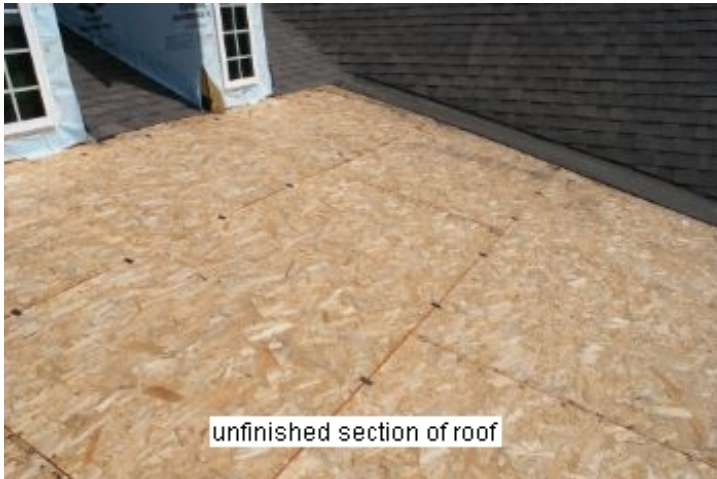
unfinished section of roof
