# *Blue Palmetto Home Inspection*

## Property Inspection Report

Home Sweet Home Street, Dream Town, SC 29461

Pre- Drywall Inspection

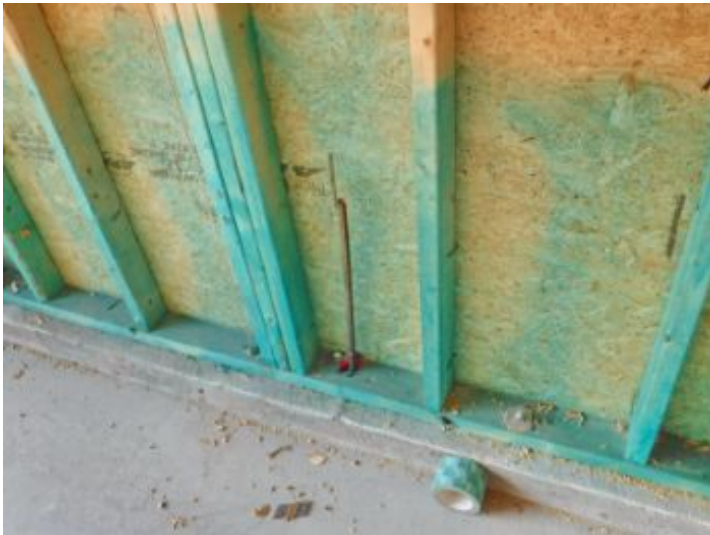
ufer type ground rod shown- incomplete at time of inspection

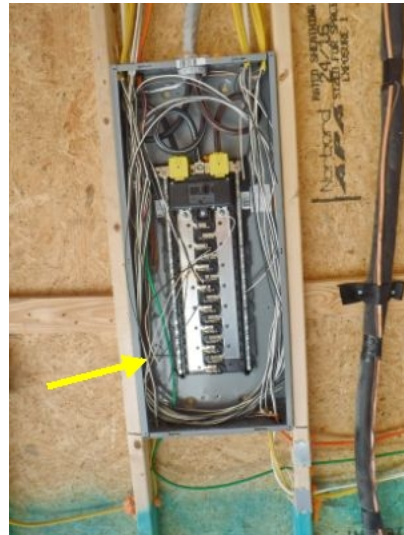
Protection (cardboard)- We highly recommend protecting the electrical panel with a sheet of cardboard or similar material to prevent the interior components from contamination by paint etc. while construction ensues. This is standard practice for many electricians and while this may seem like a minor issue an electrical panel contaminated by paint for example could mean replacement as the only option.

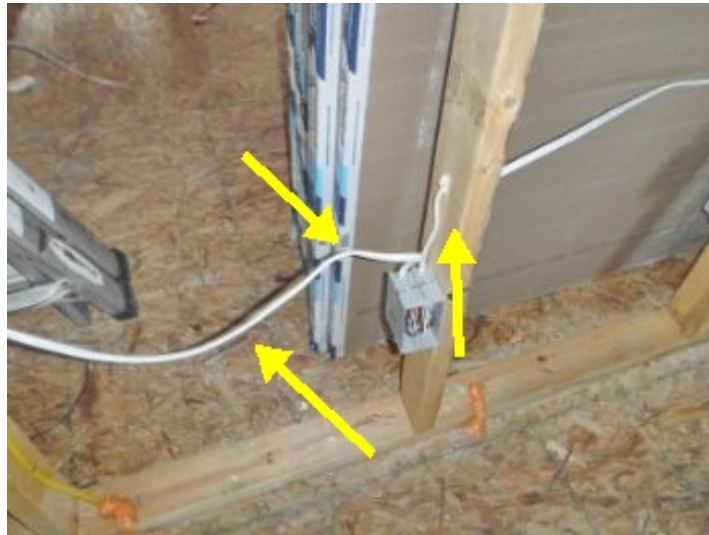
\*The conductor pictured needs to be stapled within 8" of the box. Looks like it was pulled loose from the box from foot traffic through here.

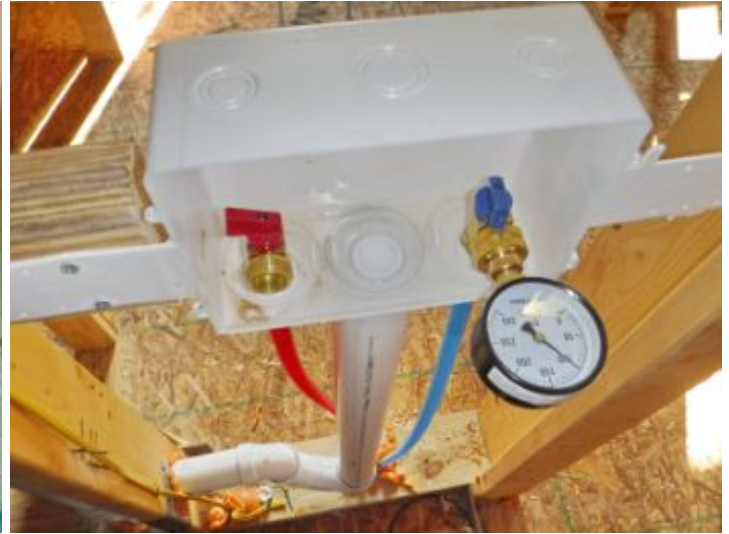
Pressure (ok)- Piping pressure gauge readings were adequate at time of inspection.(As pictured.)

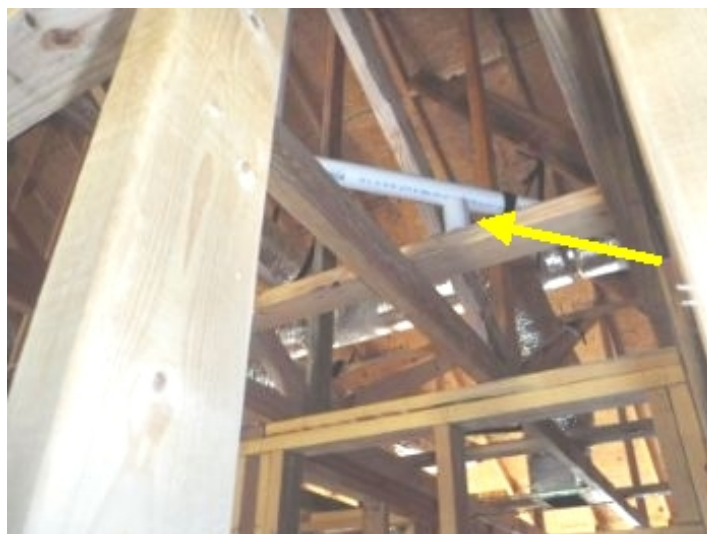
\*The plumbing drain vent stack should be tied up to prevent sagging as pictured. Right now it is just sitting on a loose piece of pvc which can be easily dislodged. If it was dislodged then the pipe would sag, fill with water where venting would be obstructed. Recommend secure it by strapping it up from above.

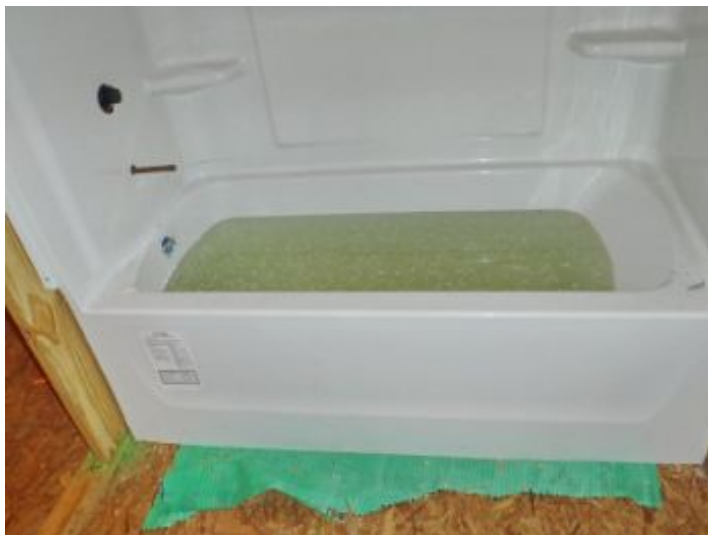
OK- Bathtubs and shower pans are normally filled with water as part of the testing process. At time of inspection it appeared that the drains piping was holding water as required and appeared leak free.

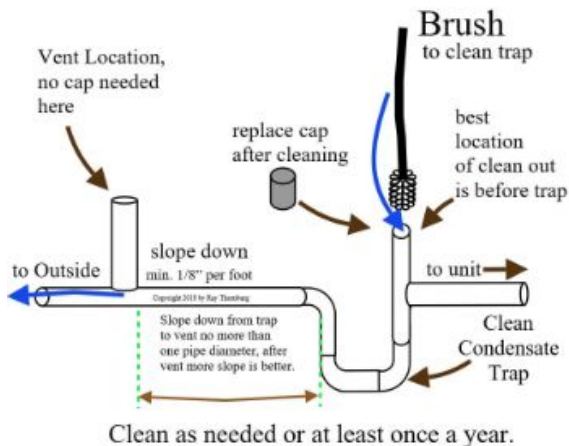
^ Recommended condensate cleaning method pictured.

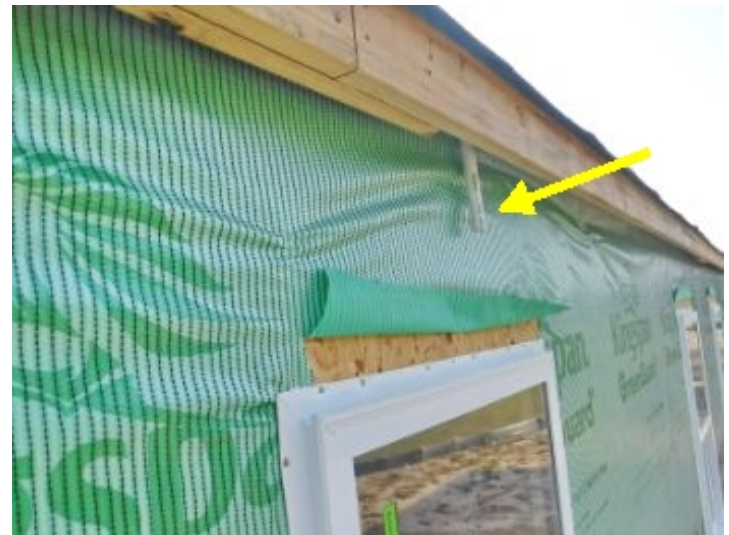
The overflow pan drain exits over the window pictured. This is a good location as it will allow the occupants to see it dripping should there be an overflow condition in the pan. If dripping is observed the owners should call for service or clear the primary drain line trap. FYI

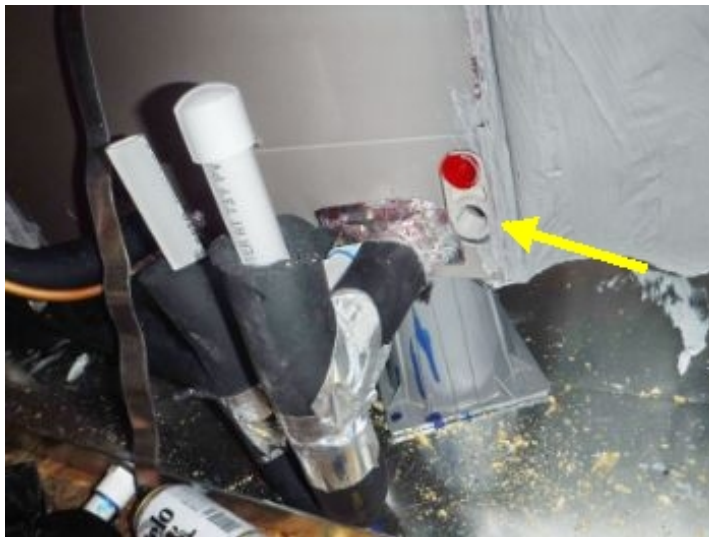
\*Unused port should be capped to prevent air from blowing out. At the condensate drain line at unit. Recommend repair.

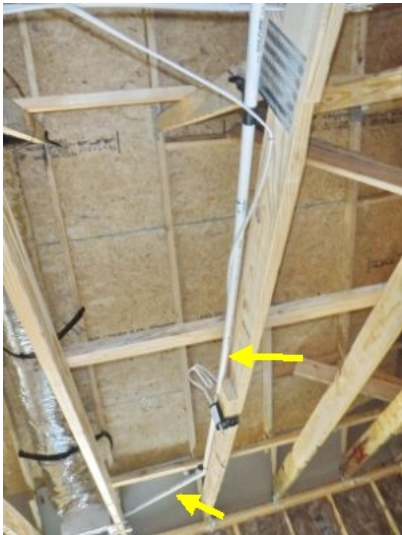
pan drain (improper slope)- The pan drain sags down then up then down. It should slope continuously downward till the exit point (over window). Recommend adjust it and secure it into position.

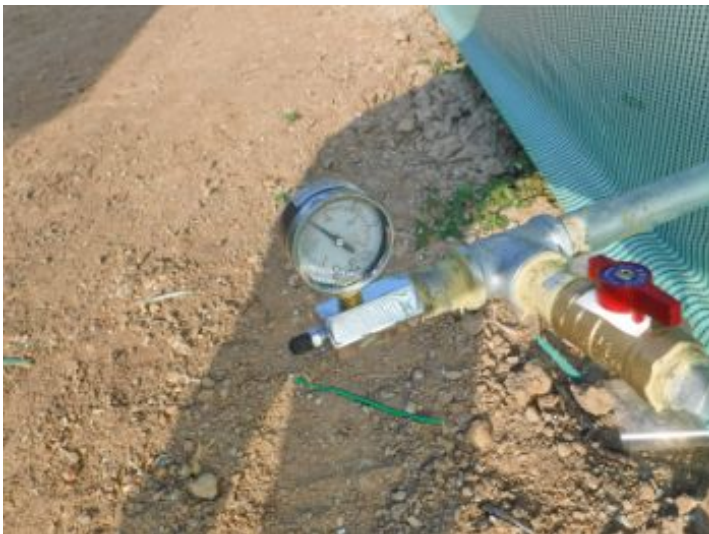
OK- Gas line pressure reading was within acceptable limits.

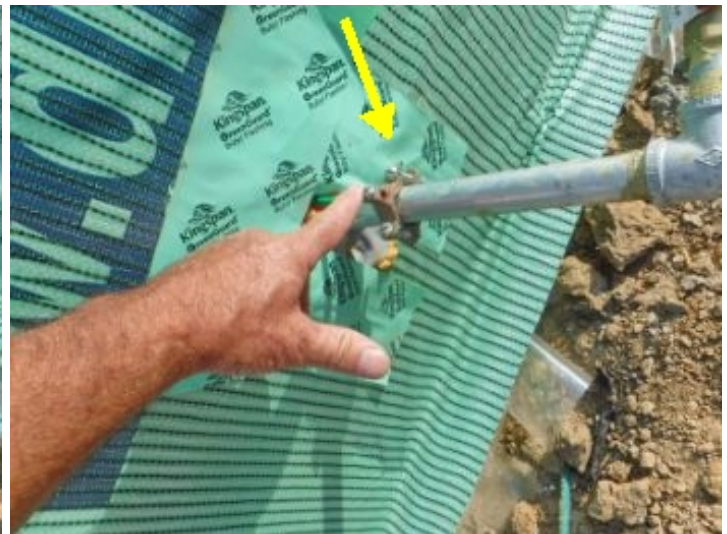
**Bonding (loose)**- Noted that the bonding clamp was loose at the gas line. It is important that the bonding clamp be tight to the pipe and the grounding conductor. Recommend tighten it up good.

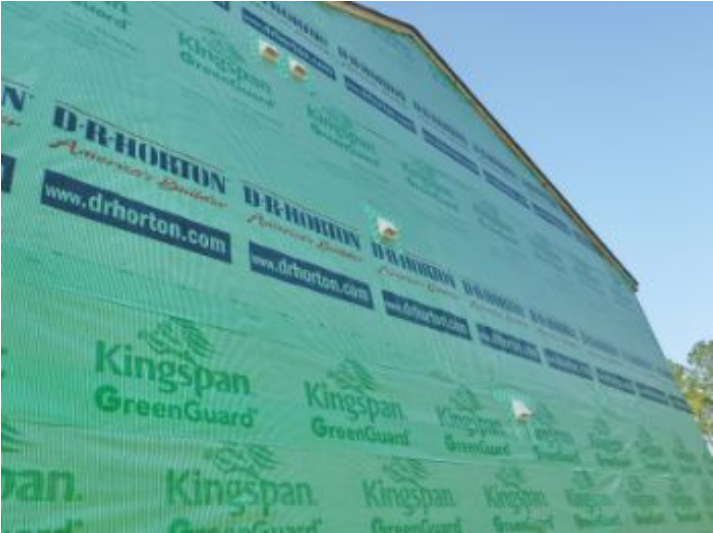
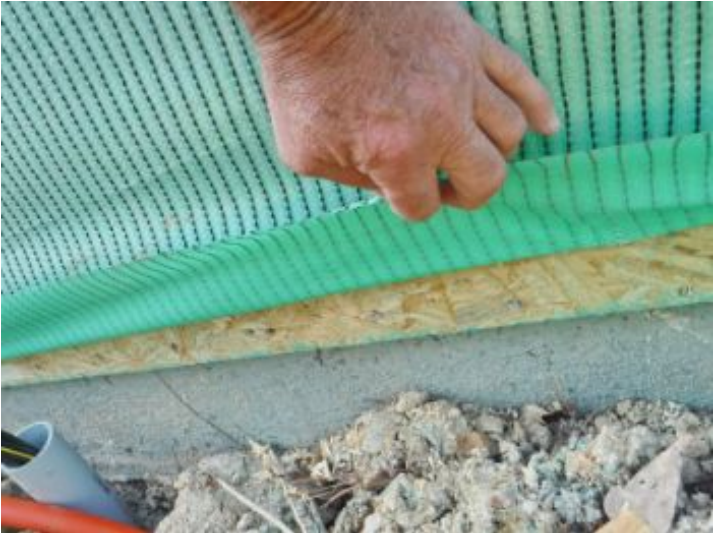
ok- Sheathing and edge blocking appear to be nailed adequately.

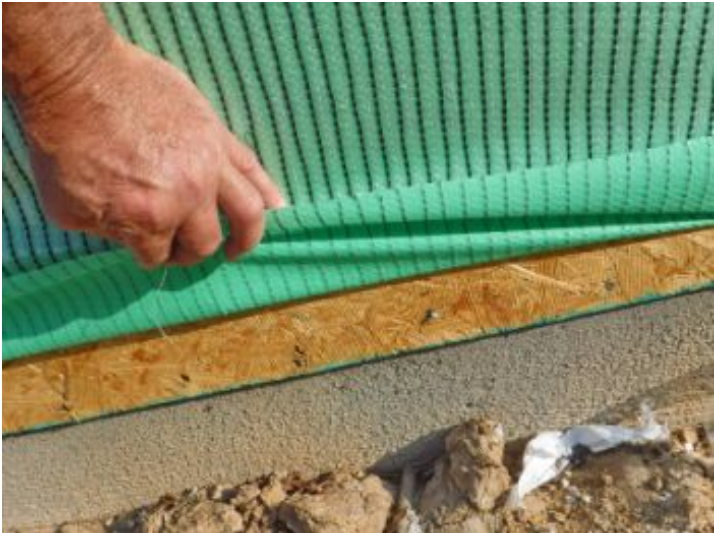
ok- Sheathing and edge blocking appear to be nailed adequately.

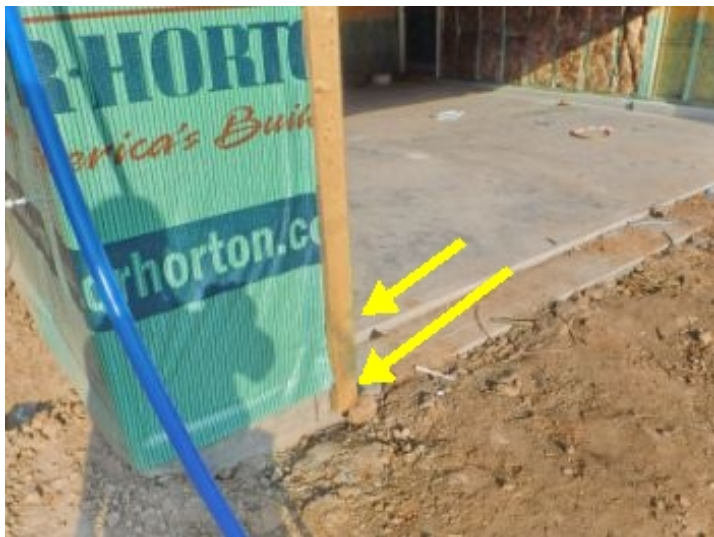
Untreated Wood - We noted some untreated wood in contact with concrete at the garage door jambs or other places as pictured. All wood that rest on concrete or masonry slab foundation or are within 8 inches of the ground are required to be pressure treated. Recommend replacing (at the very least) the bottom 2 feet of any such untreated wood to prevent decay from splashback, moisture wicking, or termites as needed. Note\* the standard for this treated wood is AWWPA U1 so simply spaying it green with preservative does not meet this standard.

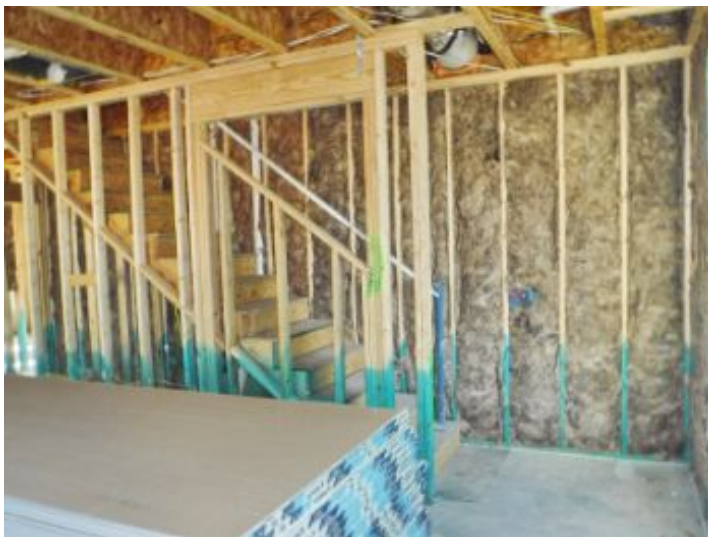
Green dye on wall studs is evidence of proper treatment.

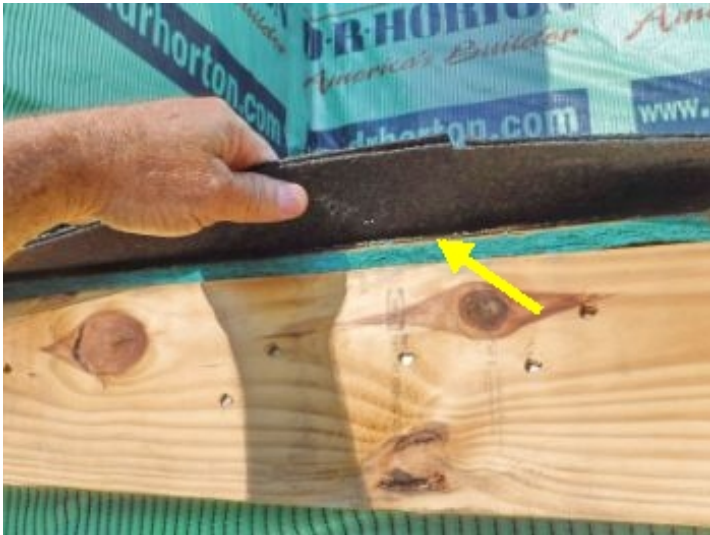
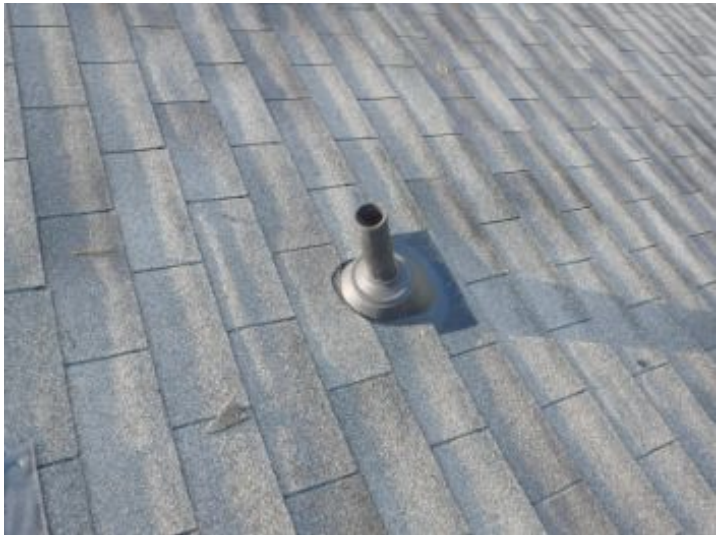
Drip Edge Missing- We noted that the metal drip edge was not installed on the home at inspection time. Drip edge is typically installed before the roof covering and has been required since the adaptation of the 2012 IRC. Though it can be installed after the shingles it is more difficult to do it correctly. Proper method as specified in the 2012 IRC is under the underlayment at eaves and over the underlayment at gables while extending 2 inches minimum on top of the roof deck. Recommendation is to have it installed.
