Blue Palmetto Home Inspection

Home Inspection Report

123 American Dream Street, Summerville, SC 29483
Inspection prepared for: Charles Sample
Real Estate Agent: Support - Home Inspector Pro

Date of Inspection: 2-27-2018 Time: 10:00 am
Age of Home: built in 2004 (not verified) Size: 1418 sf heated (not verified)
Weather: sunny and mild
Buyers Inspection
Sample Report

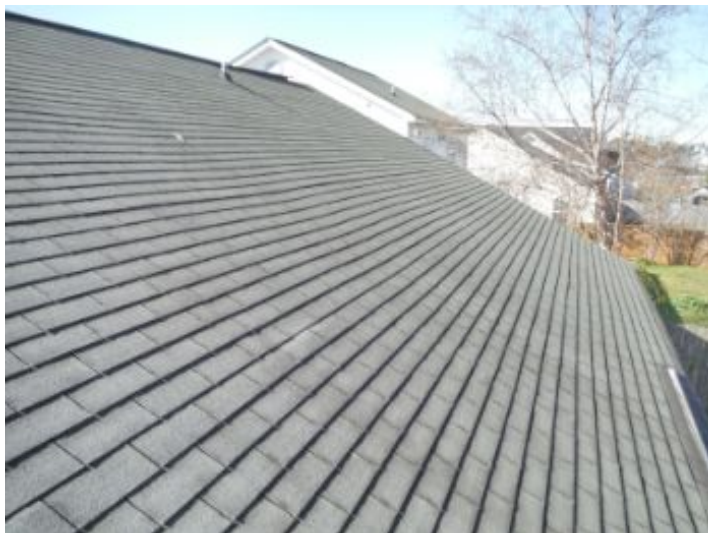
Nail pop pictured. Repair as needed to prevent
moisture intrusion.

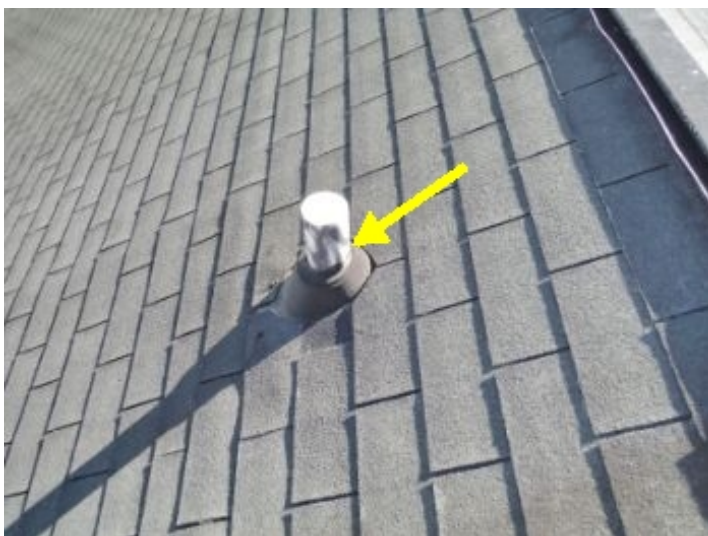
fasteners backing up- seal it up

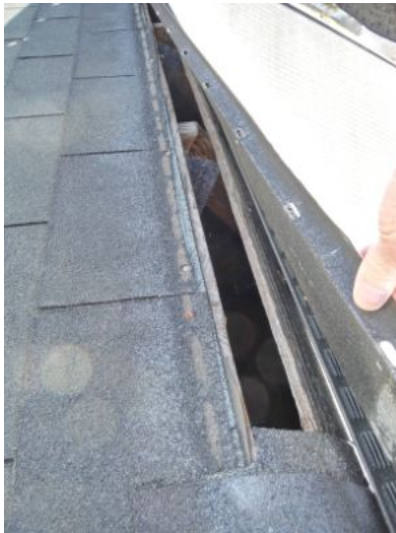
Ridge Vents (loose)- Ridge vents are coming loose in some areas enough to allow moisture or vermin into the attic area. Recommend repair as needed.

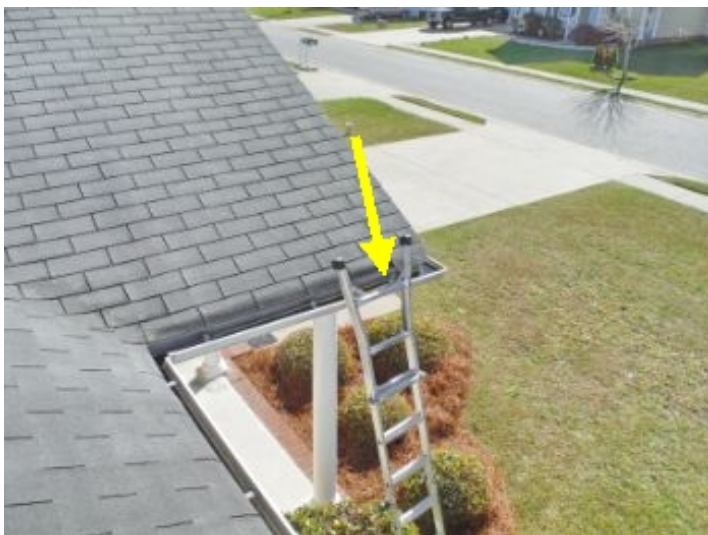
Slope (improper)- Gutter is improperly tilted away from the downspout at the location pictured. This is causing the gutter to hold water and can cause an accumulation of debris and cause stress on guttering which is not designed to hold water only to drain it. Recommend adjust as needed.

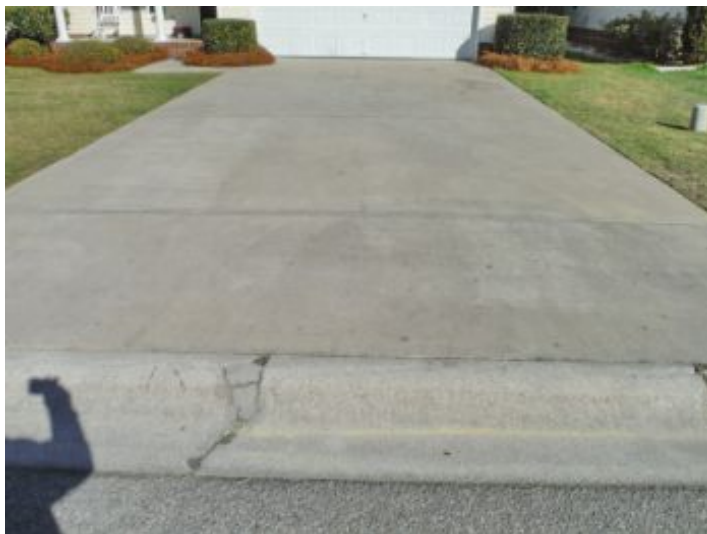
- minor to moderate cracking noted in driveway. Monitor for future expansion.

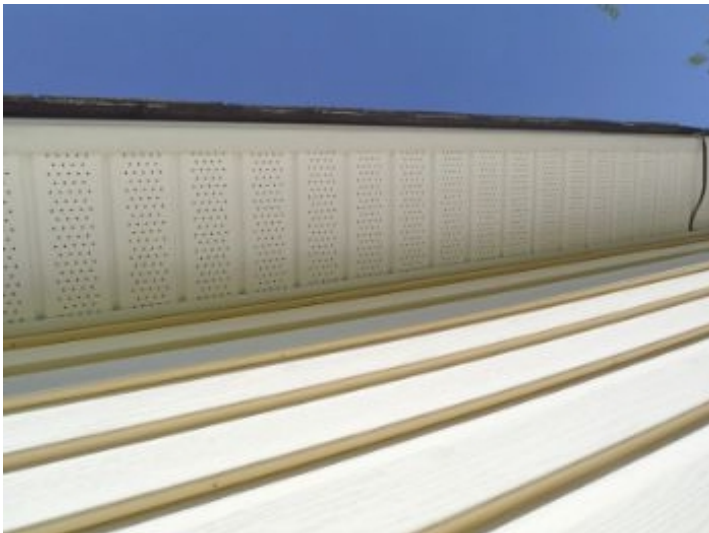
- *Metal trim at corner needs to be tightened up as it has a gap.

*Metal trim at corner needs to be tightened up as it has a gap.

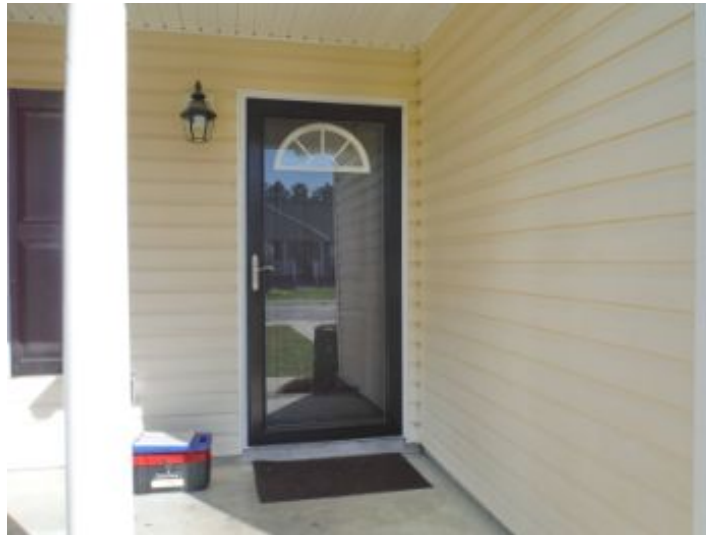
- The front door indicated the following condition - minor dings noted. We recommend repair as needed.

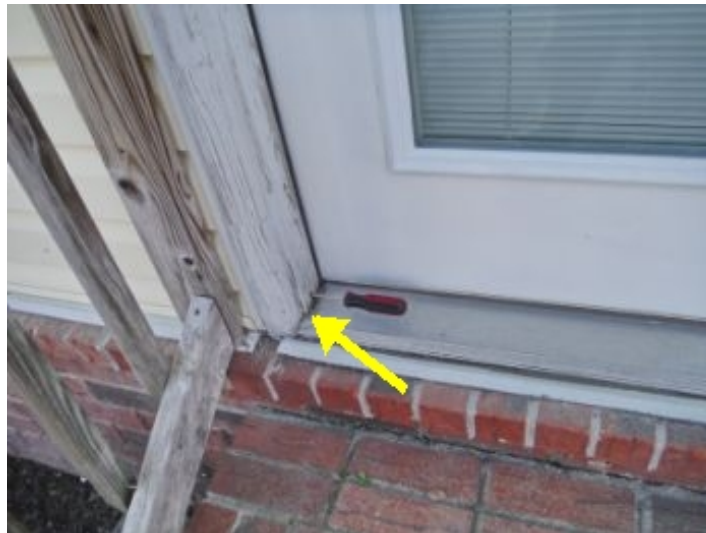
- The back door indicated the following condition - rotted or moisture damaged jambs at bottom. We recommend repair as needed.

The back door indicated the following condition - rotted or moisture damaged jambs at bottom. We recommend repair as needed.

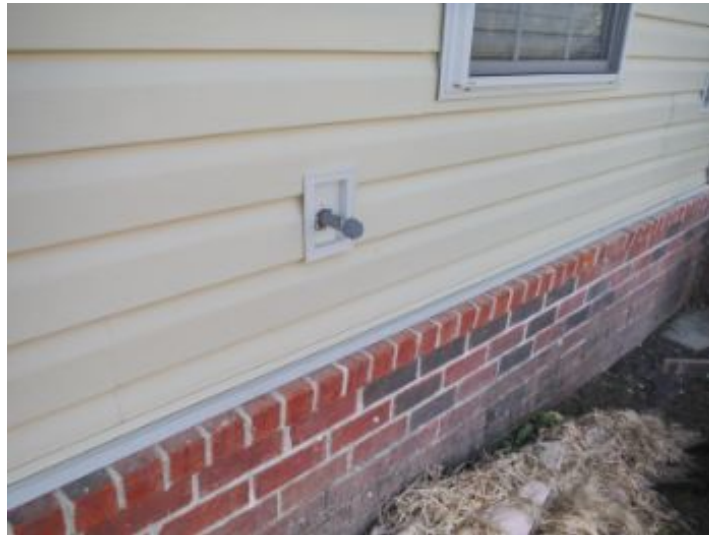
- There is no propane tank present. Line stub out is capped.

There is no propane tank present. Line stub out is capped.

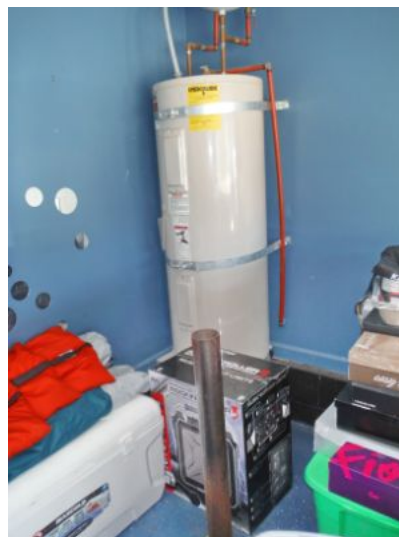
Water Temp (reading)- The water temperature at faucet is reading 120-125 degrees which is considered hot.

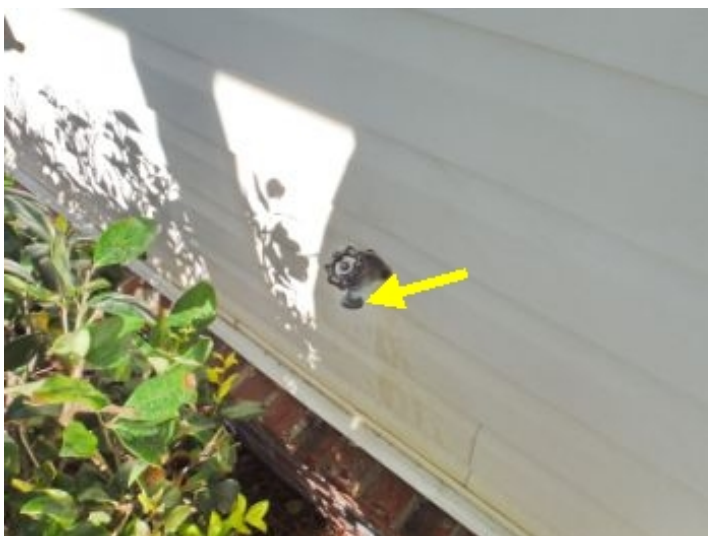
- *Absent (all)- Noted not present on hose bibs.(anti backflow devices) Recommend improve. Explanation- An anti- backflow device on a hose bib is a device that only allows water to flow one way in order to protect the water supply from possible contamination. They usually screw onto the hose bib and are inexpensive to replace if needed. More modern regulations require them.

- *Absent (all)- Noted not present on hose bibs.(anti backflow devices) Recommend improve. Explanation- An anti- backflow device on a hose bib is a device that only allows water to flow one way in order to protect the water supply from possible contamination. They usually screw onto the hose bib and are inexpensive to replace if needed. More modern regulations require them.
- *Absent (all)- Noted not present on hose bibs.(anti backflow devices) Recommend improve. Explanation- An anti- backflow device on a hose bib is a device that only allows water to flow one way in order to protect the water supply from possible contamination. They usually screw onto the hose bib and are inexpensive to replace if needed. More modern regulations require them.

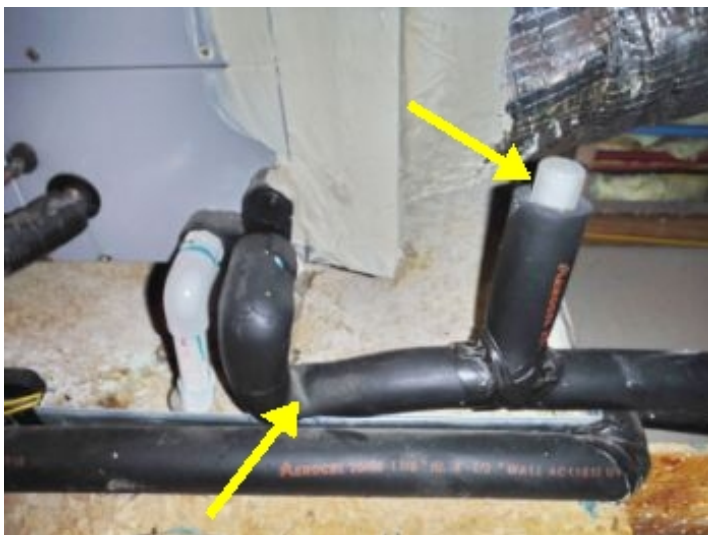
****CLEAN TRAP**** Gunk or other buildup noted in the condensate trap. When traps clog a backup will happen. Recommend cleaning.

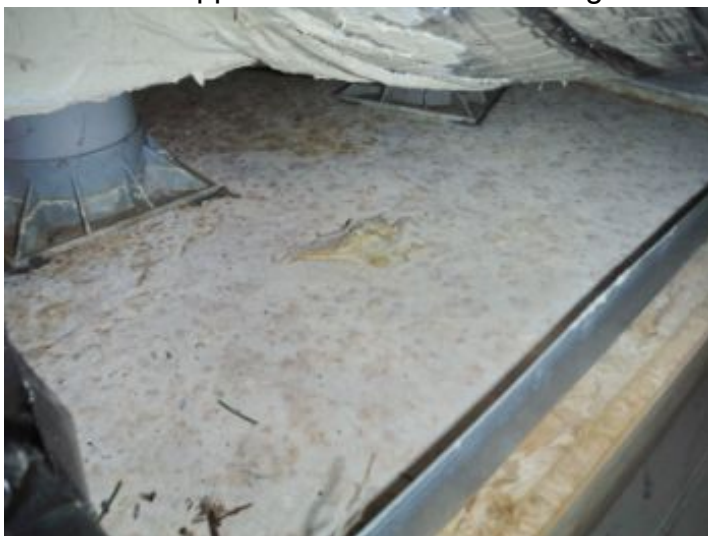
*There was rust or efflorescence in the overflow drain pan. Normally the overflow pan should be empty and the presence of rust and efflorescence indicates that the primary pan drain was blocked at some point in time and overflowing into the secondary pan. Efflorescence is a type of white powdery salt left behind when water evaporates repeatedly. Recommend evaluation/improvements by a qualified HVAC contractor to make sure this does not happen again or regular maintenance, (keep the trap clean).

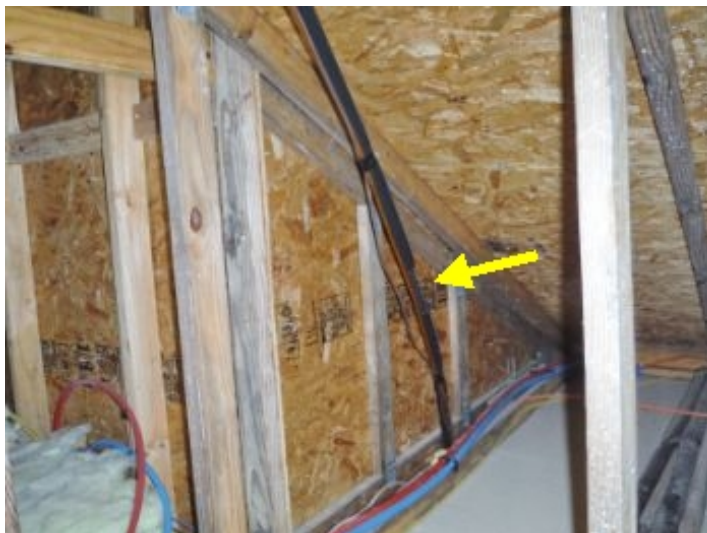
- Missing insulation on parts of refrigerant line as pictured. Even a small gap can cause condensation which could damage building materials. Recommend improve.

Missing insulation on parts of refrigerant line as pictured. Even a small gap can cause condensation which could damage building materials. Recommend improve.

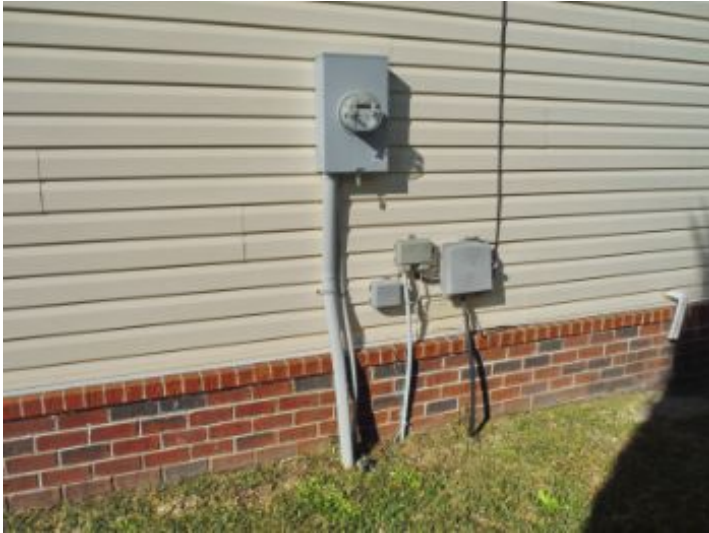
- **Ground Rod** (above grade)- The **ground rod** is sticking up a little. The **ground rod** should be fully driven flush, below grade or protected. Grounding conductors should be protected where subject to damage. This is to protect it from accidental damage from lawn mowers, weed eaters etc.

Ground Rod (above grade)- The ground rod is sticking up a little. The ground rod should be fully driven flush, below grade or protected. Grounding conductors should be protected where subject to damage. This is to protect it from accidental damage from lawn mowers, weed eaters etc.

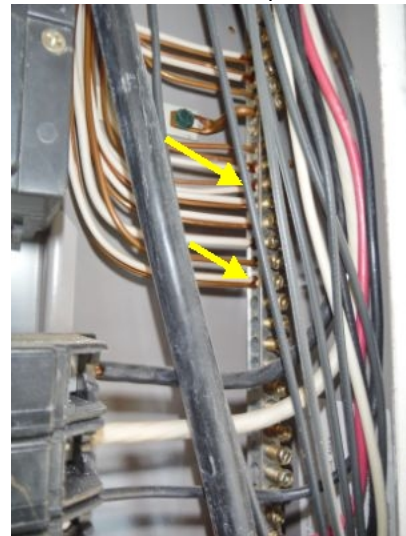
DT Neutrals & Grounds- There are double tapped neutrals and grounding conductors in the panel. This is where two (or more) conductors (a neutral and a grounding conductor) are under a screw terminal designed for one conductor. This is not currently allowed. Note- In past years the language in some codes may have been vague (though apparently this practice was quite common) This practice is now specifically prohibited; History Note In 2002 the language in the NEC was clarified based on the UL listing of every panel made since 1965. Therefore it has been disallowed since at least 1965. In most cases the solution is simply to move the conductor to another terminal (by a qualified electrician). Consider improvement.

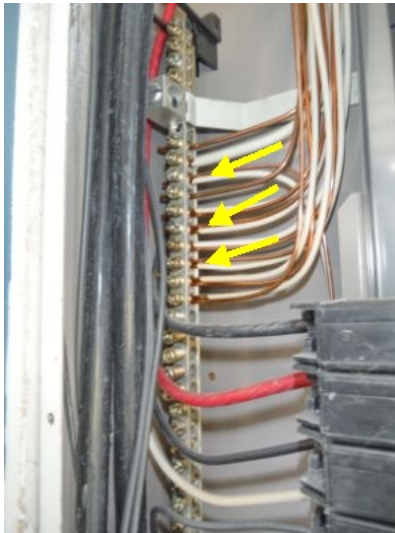
DT Neutrals & Grounds- There are double tapped neutrals and grounding conductors in the panel. This is where two (or more) conductors (a neutral and a grounding conductor) are under a screw terminal designed for one conductor. This is not currently allowed. Note- In past years the language in some codes may have been vague (though apparently this practice was quite common) This practice is now specifically prohibited; History Note In 2002 the language in the NEC was clarified based on the UL listing of every panel made since 1965. Therefore it has been disallowed since at least 1965. In most cases the solution is simply to move the conductor to another terminal (by a qualified electrician). Consider improvement.

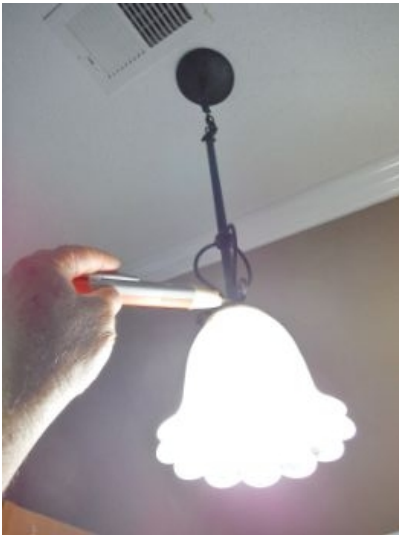
Hanging Pendant (grounding)- It appears this hanging pendant is not grounded properly (several noted). The metal parts of light fixtures have been required to be grounded since 1975. Consider improving for safety.

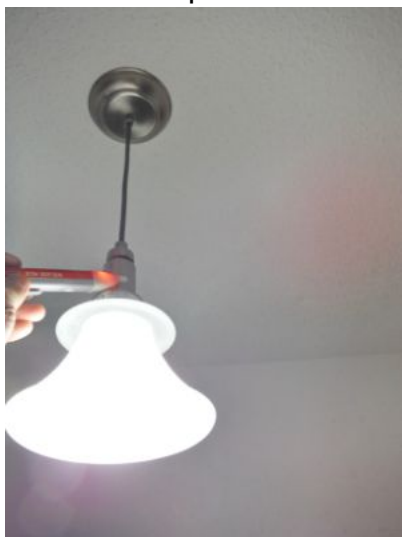
Hanging Pendant (grounding)- It appears this hanging pendant is not grounded properly (several noted). The metal parts of light fixtures have been required to be grounded since 1975. Consider improving for safety.

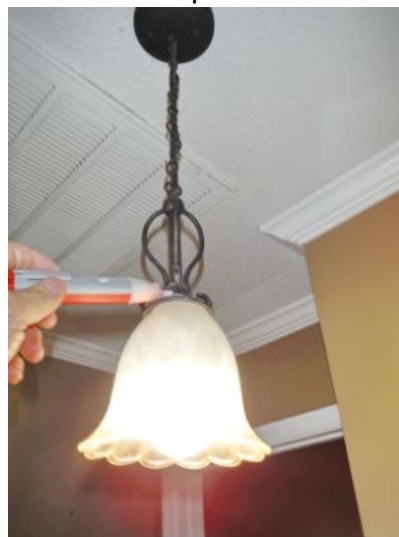
Hanging Pendant (grounding)- It appears this hanging pendant is not grounded properly (several noted). The metal parts of light fixtures have been required to be grounded since 1975. Consider improving for safety.

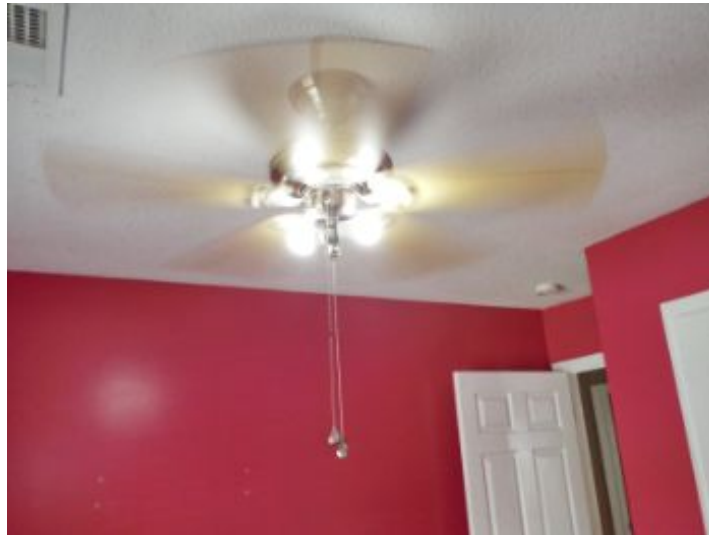
Some ceiling fans though operational were missing parts like light globes etc. Recommend improve.

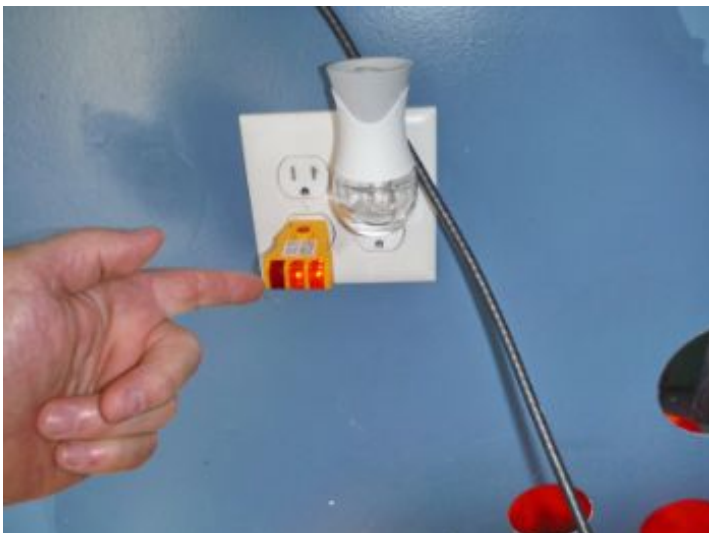
***Not Protected (location pictured)-** The garage receptacles pictured did not test positive for GFI protection. Consider improving for safety.

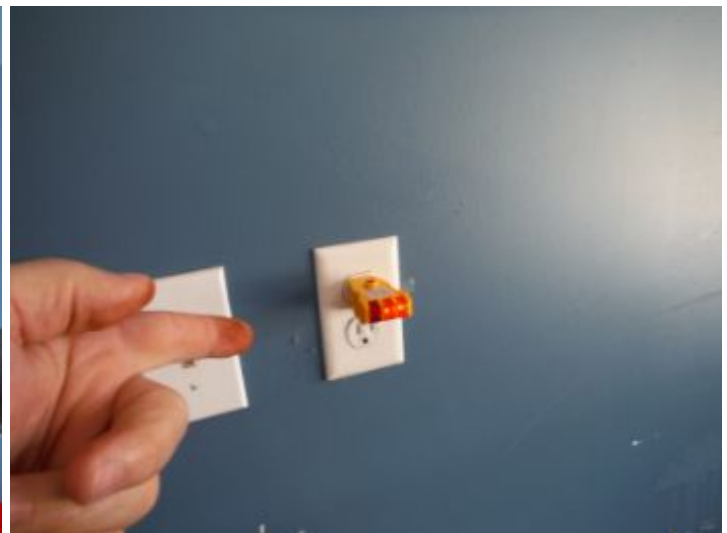
***Not Protected (location pictured)-** The garage receptacles pictured did not test positive for GFI protection. Consider improving for safety.

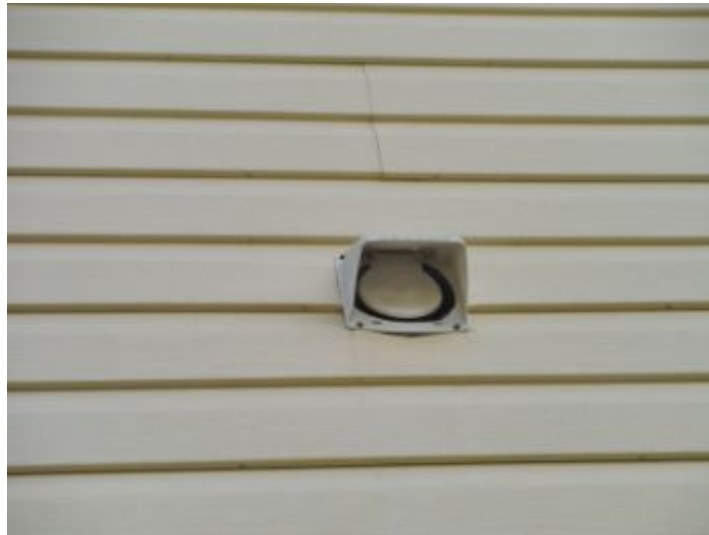
The dryer vent is present but it has seen better days. It does not appear to be well fitted. Consider replacing it in the near future. Recommend occasional inspection and cleaning of dryer vent and termination exit point to ensure optimum performance.

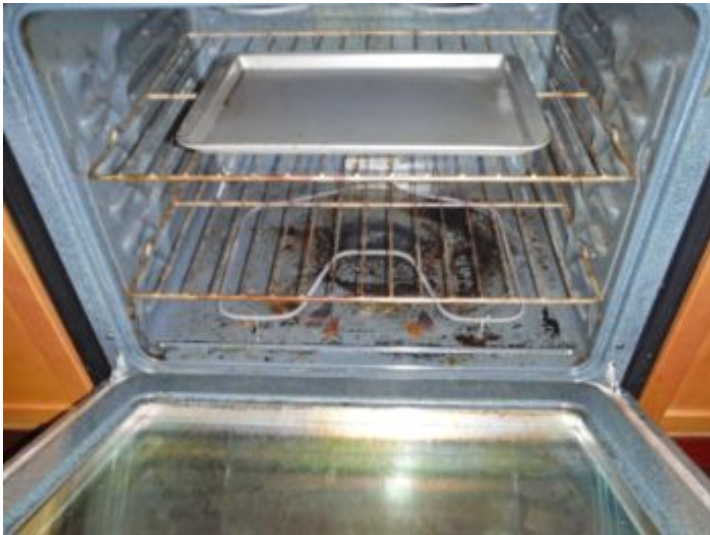
Cleaning- Oven needs cleaning inside.

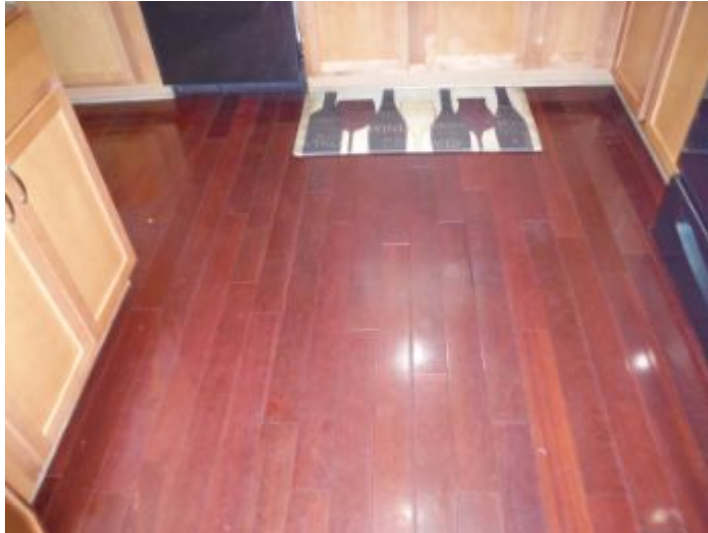
*Floor is not well adhered in some places. It made a noise in those areas when stepped on.

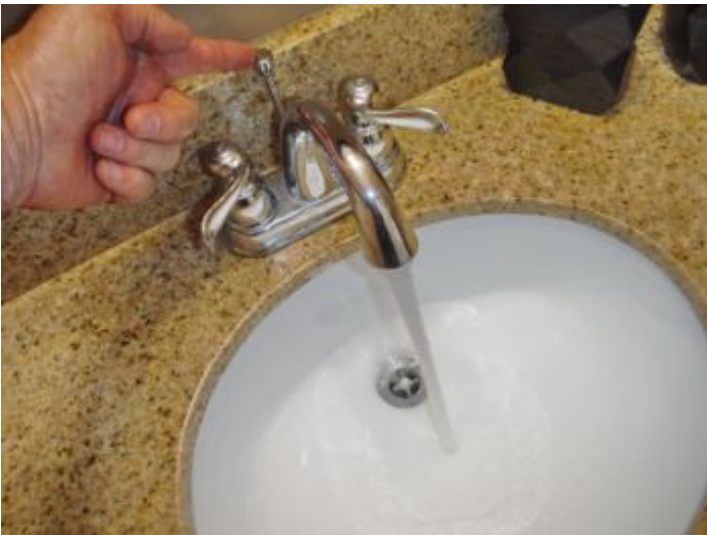
Stopper (missing)- Stopper is missing/inoperable.
Repair as needed.

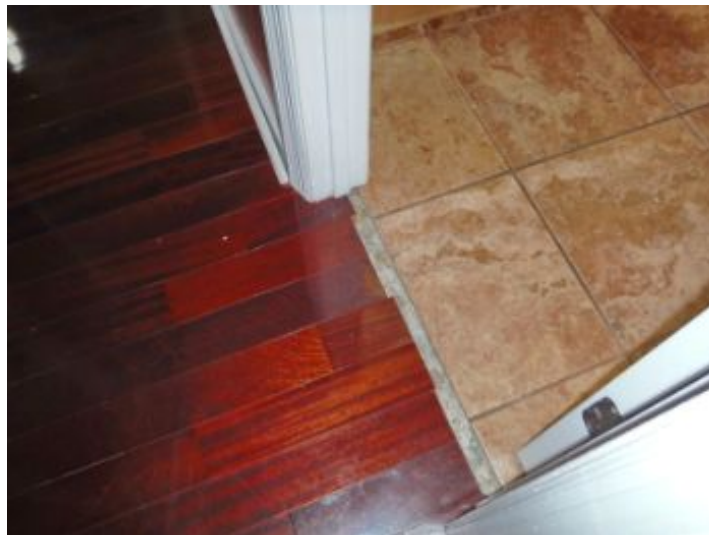
*Transition piece is missing at bathroom door threshold. Recommend replace as needed.

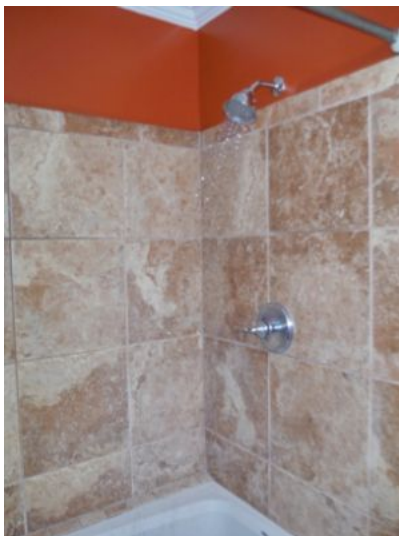
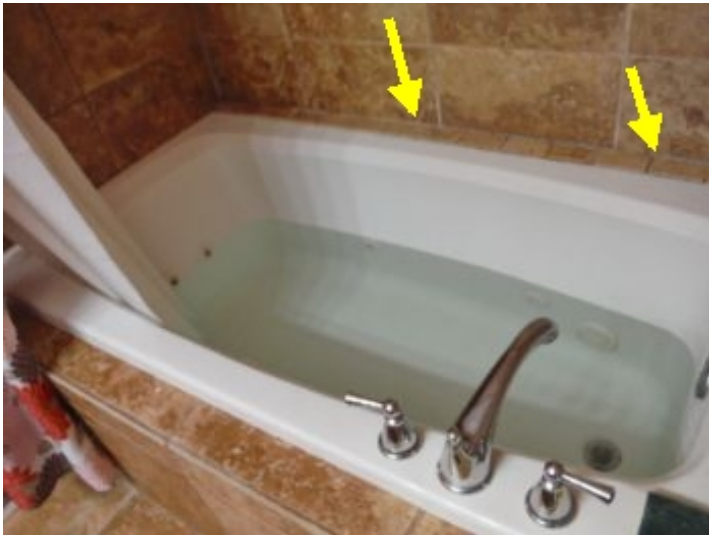
• *I believe that the way the tile is laid it can allow water to drain behind the tub. Some evidence of this was observed. Loose tiles observed. Recommend contact an experienced tub, shower installer and tile expert to solve this issue.

*I believe that the way the tile is laid it can allow water to drain behind the tub. Some evidence of this was observed. Loose tiles observed. Recommend contact an experienced tub, shower installer and tile expert to solve this issue.

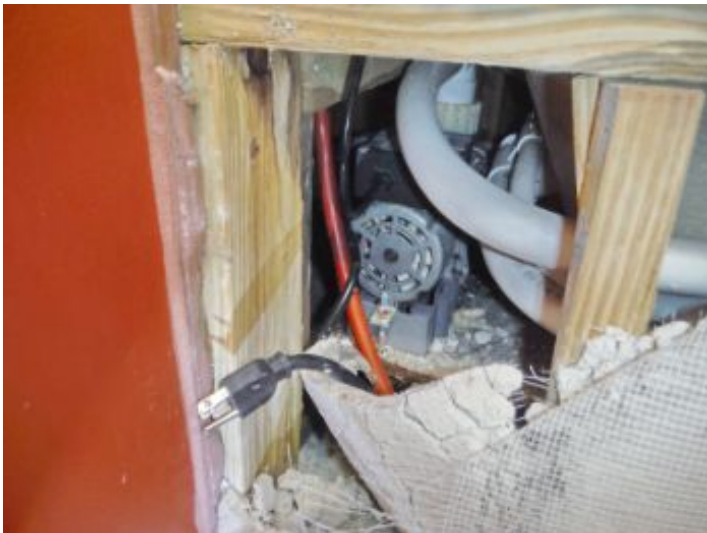
*Jetted motor could not be tested for lack of a power source. Jetted tub motors are required to be on their own circuit and GFI protected. The motor is required to be accessible. A qualified electrician can do this for you.

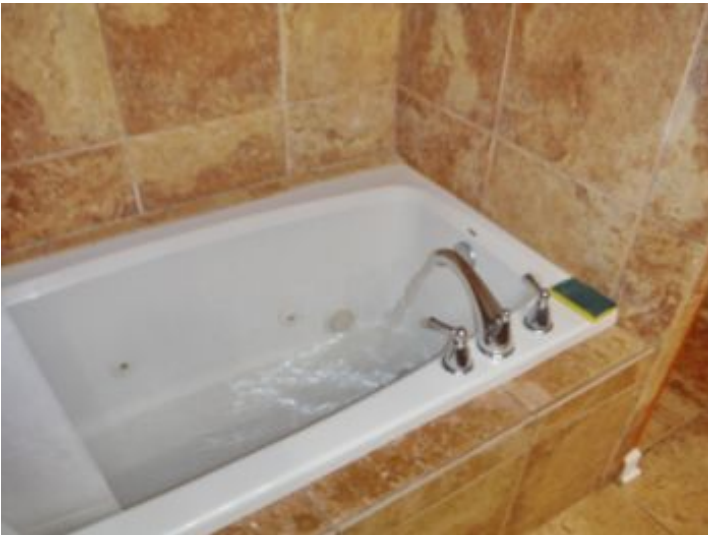
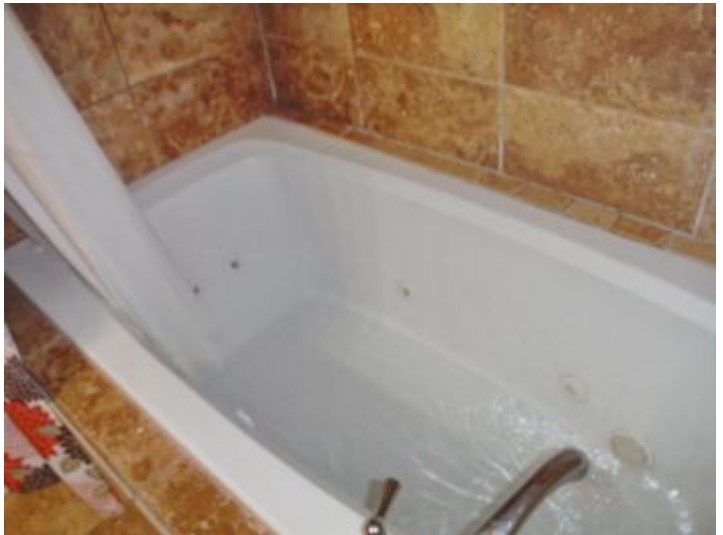
*The installation of the access panel for the tub motor was not complete. Broken tile observed. Recommend have the jetted tub and its components installed before closing.

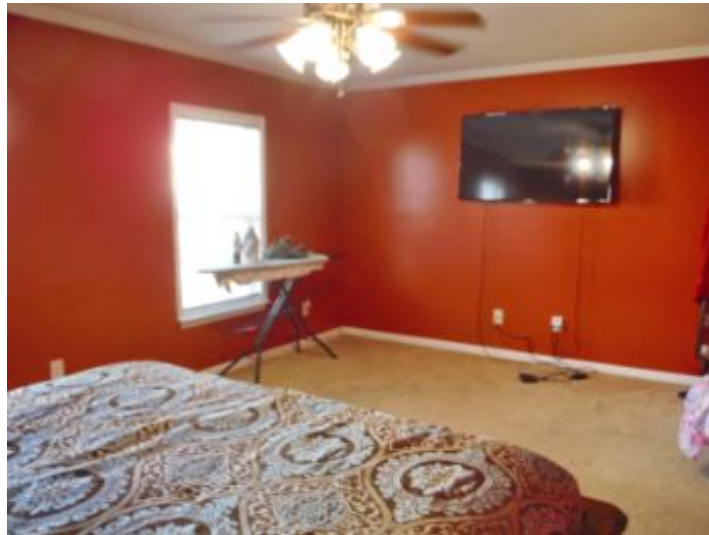
- Some minor dings or cracks noted. Repair as needed.

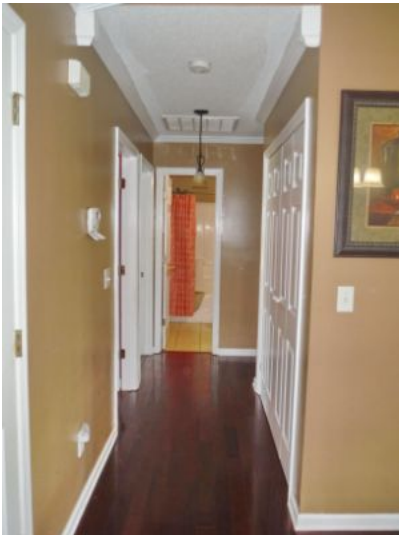
Noted several holes in the wall and some incomplete patch jobs. Some are pictured. Recommend review all with seller before closing and have them repaired. Note(It is beyond the scope of a home inspection to document every ding and picture hanging hole.)

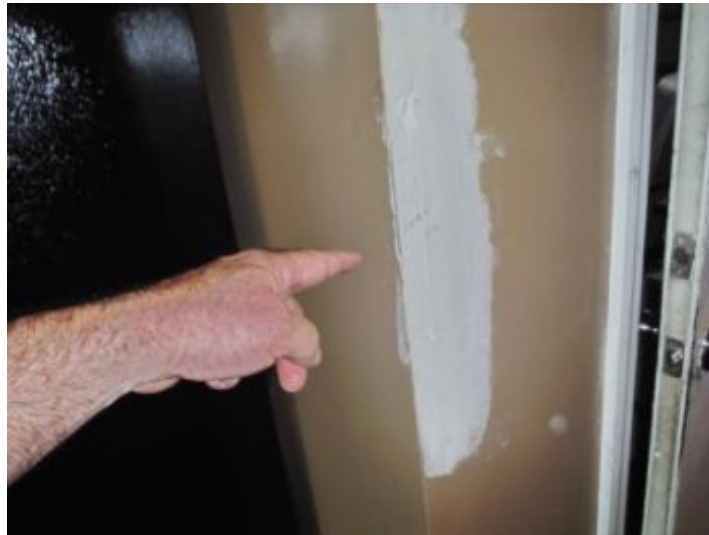
Noted several holes in the wall and some incomplete patch jobs. Some are pictured. Recommend review all with seller before closing and have them repaired. Note(It is beyond the scope of a home inspection to document every ding and picture hanging hole.)

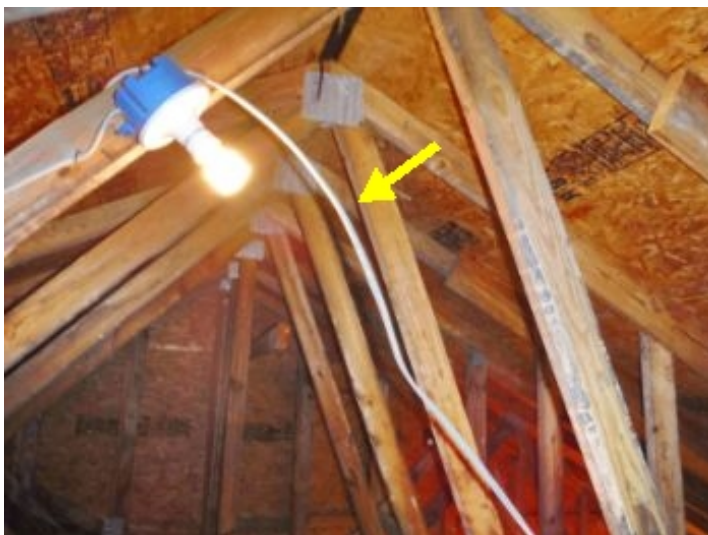
J Box Covers- Noted A junction boxes without a suitable cover, which is a safety concern. As pictured. Recommend installing proper covers, as needed, for safety. In addition boxes need to be properly attached to framing as required. Wires properly stapled to framing within 8" of box. If metal boxes are used then they are required to be bonded (grounded) with strain relief clamps in place. Recommend repair all as needed.
