# *Blue Palmetto Home Inspection*

## Property Inspection Report

Home Sweet Home Street, Dream Town, SC 29461

Pre- Drywall Inspection

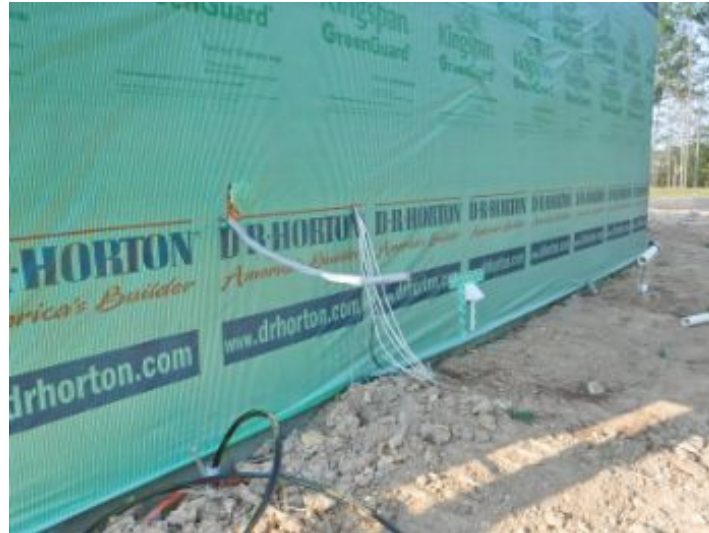
Incomplete- Meter base is not set at the time of inspection.

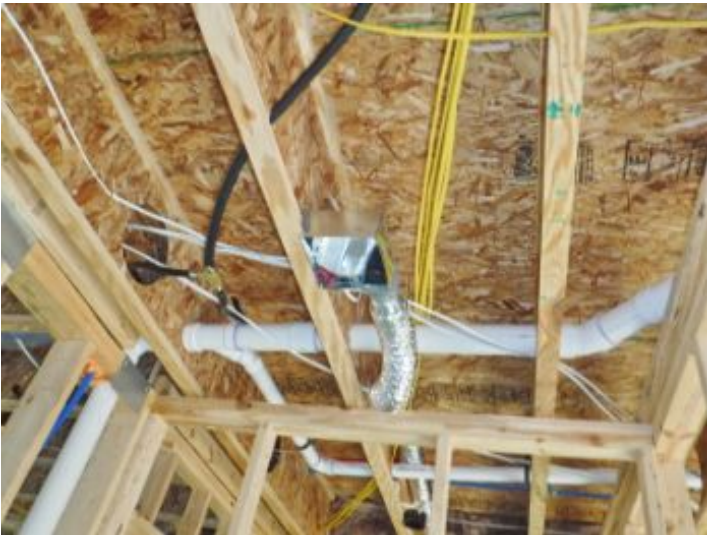
Bathroom fans pictured.

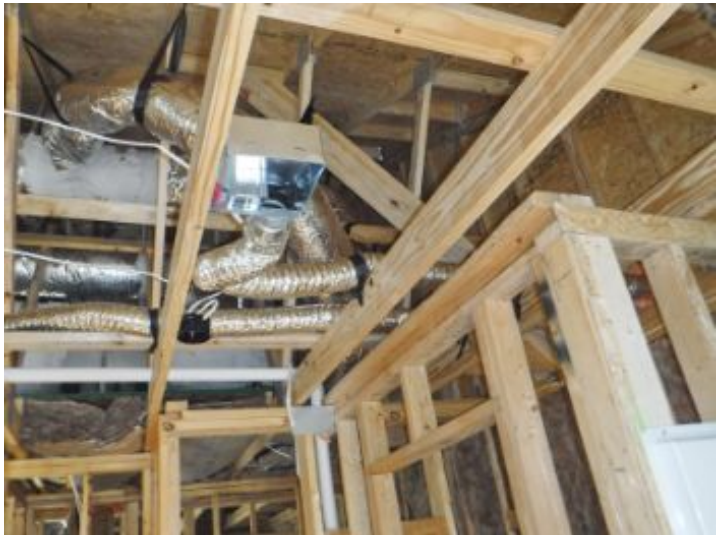
Bathroom fans pictured.

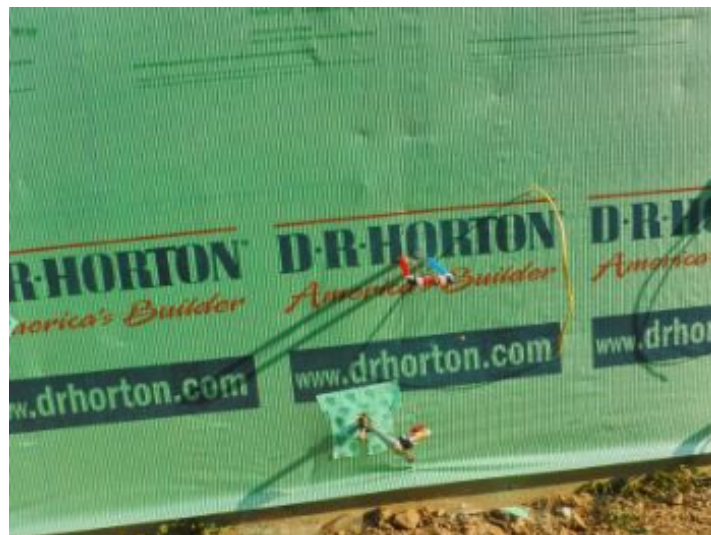
Shows where water heater will be located.

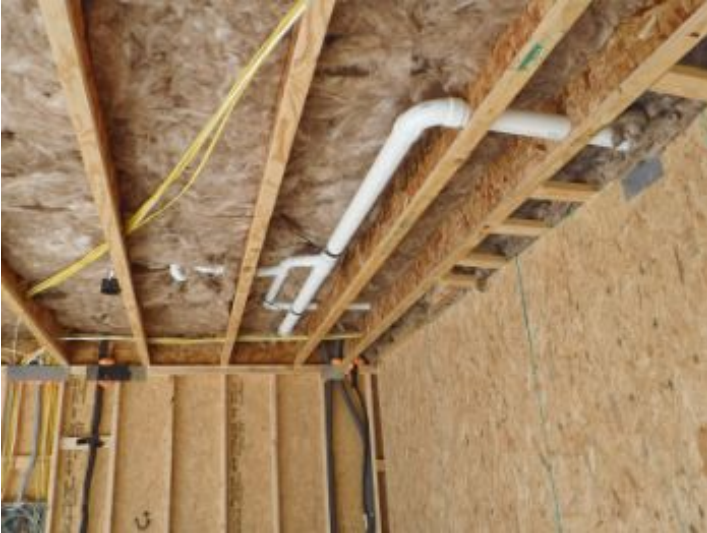
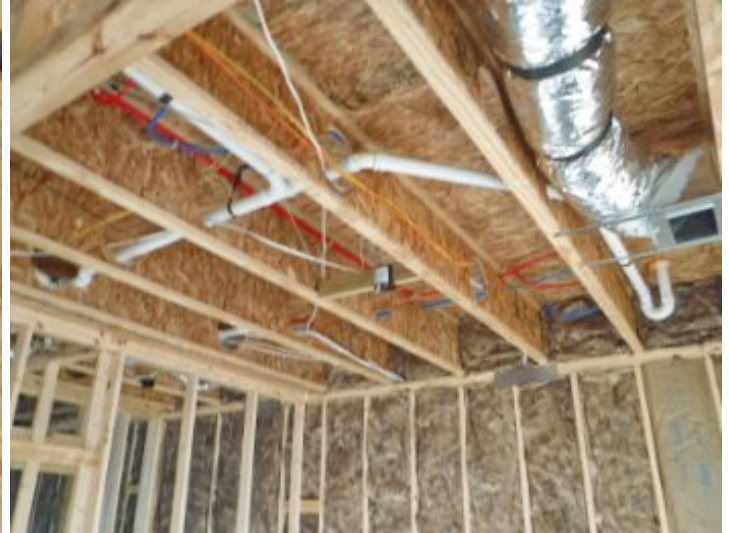
- OK- (drain testing)- Drain lines are filled with water and appear to have no leaks at time of inspection.

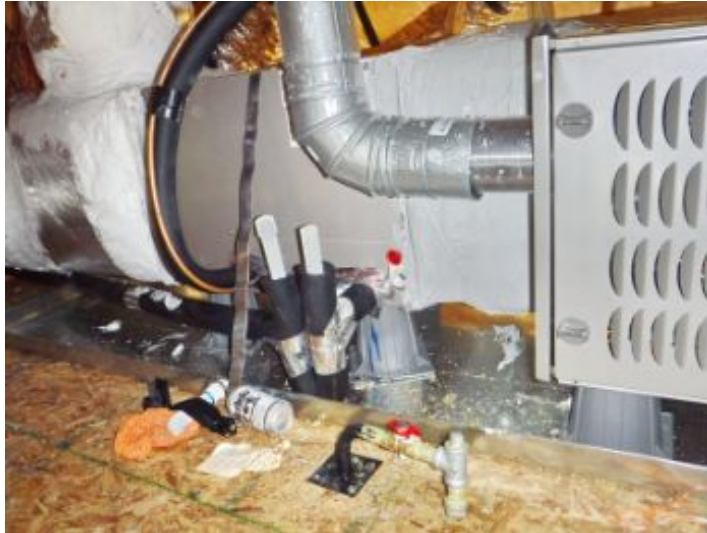
Air Handler brand name is Carrier.

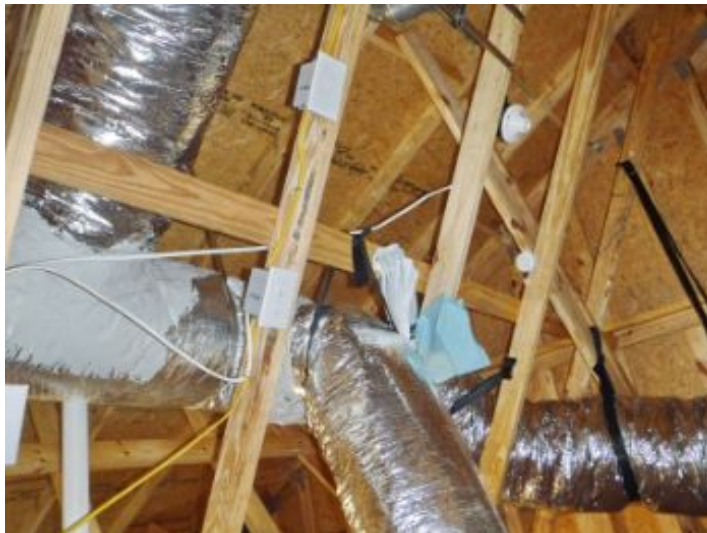
Proper workspace to unit and light provided- ok

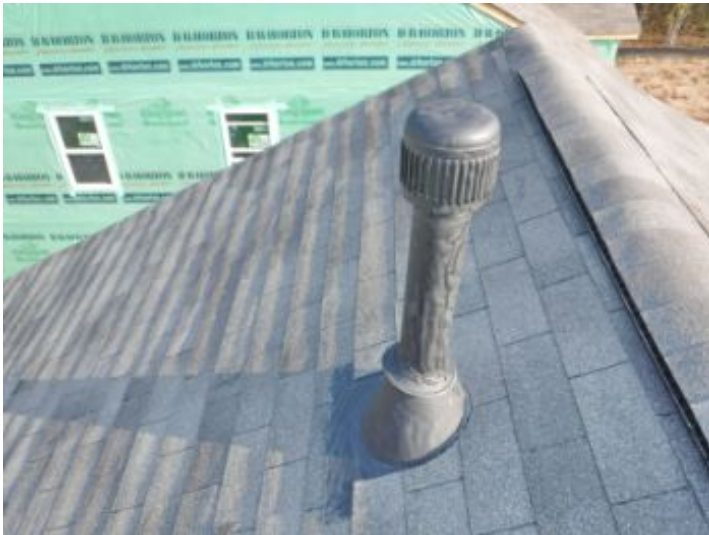
Metal double wall type B vent pipe noted.

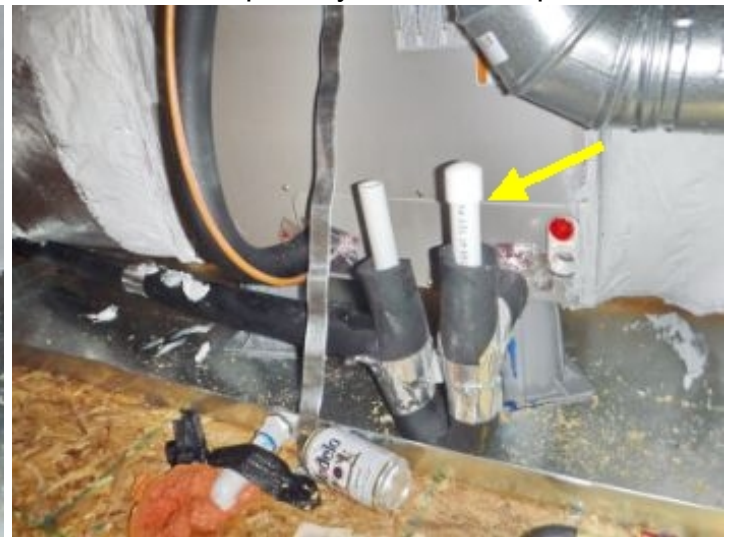
\*Unused port should be capped to prevent air from blowing out. At the condensate drain line at unit. Recommend repair.

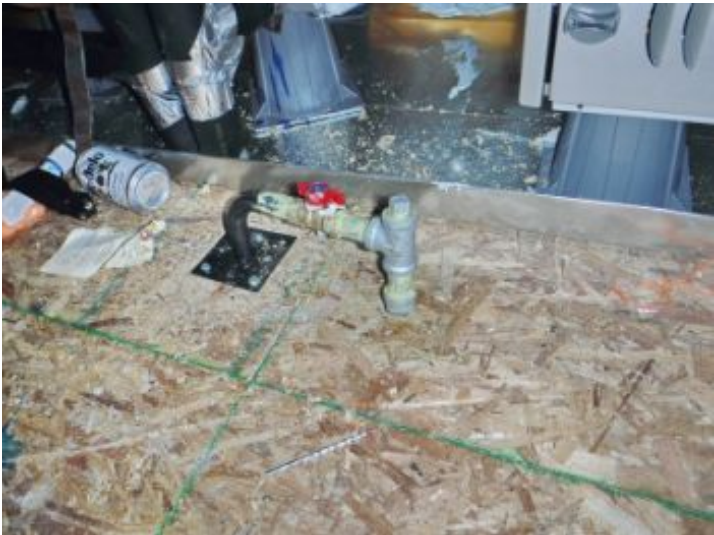
**Bonding (loose)**- Noted that the bonding clamp was loose at the gas line. It is important that the bonding clamp be tight to the pipe and the grounding conductor. Recommend tighten it up good.

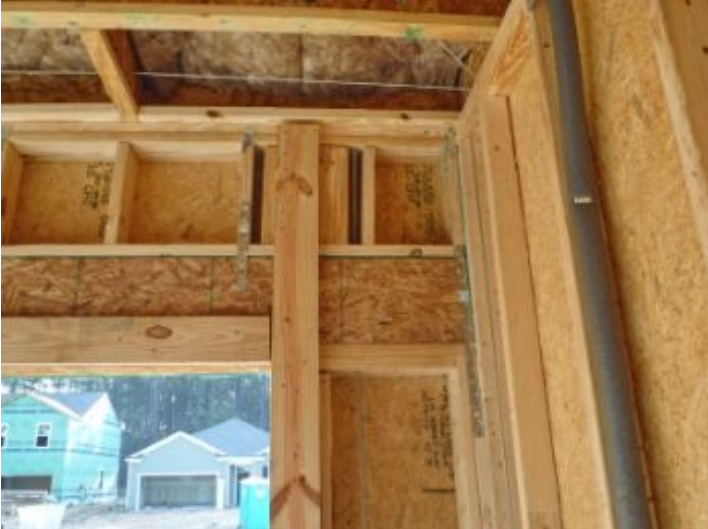
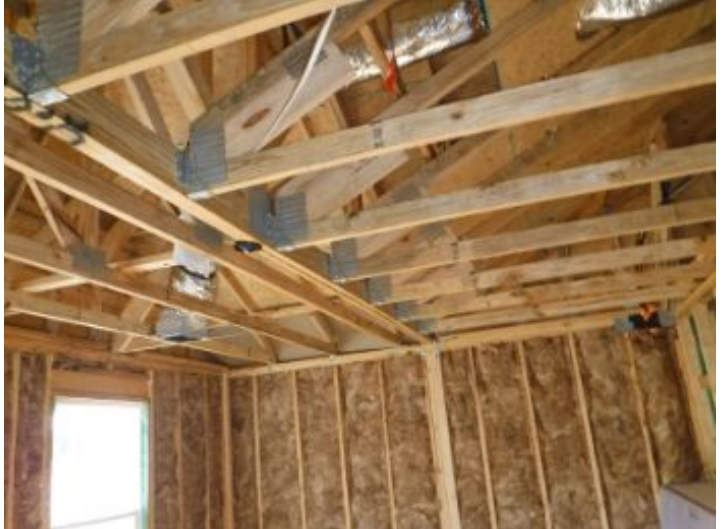
- anchor bolts noted
- Anchor bolts and "cabletite" or similar cable system in place to meet wind uplift resistance. These systems use a cable that stretches through to the top plate so some other strapping may not be necessary.

Anchor bolts or other wall anchoring methods pictured.

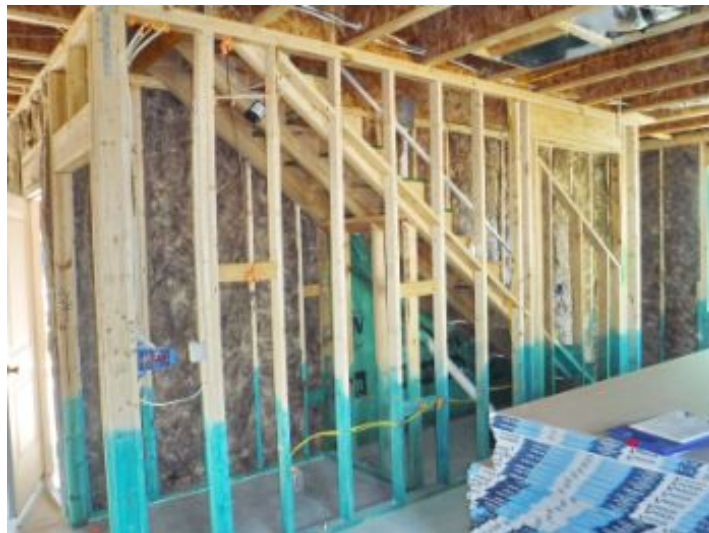
**Materials:** all usual locations fire blocked properly • Fire blocking - Fire blocking is a piece 2x4 or 3/4" plywood or similar material place at the junction between floor levels or ceiling to wall junctions. It's purpose is to slow the spread of flames in case of fire. **FYI**

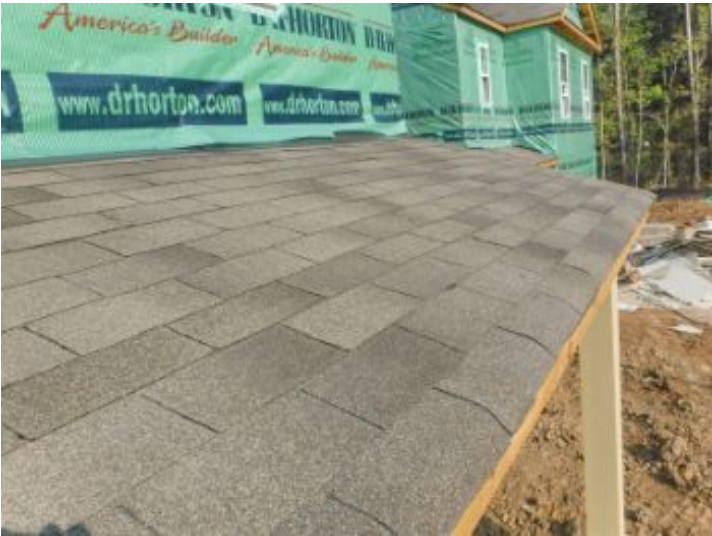
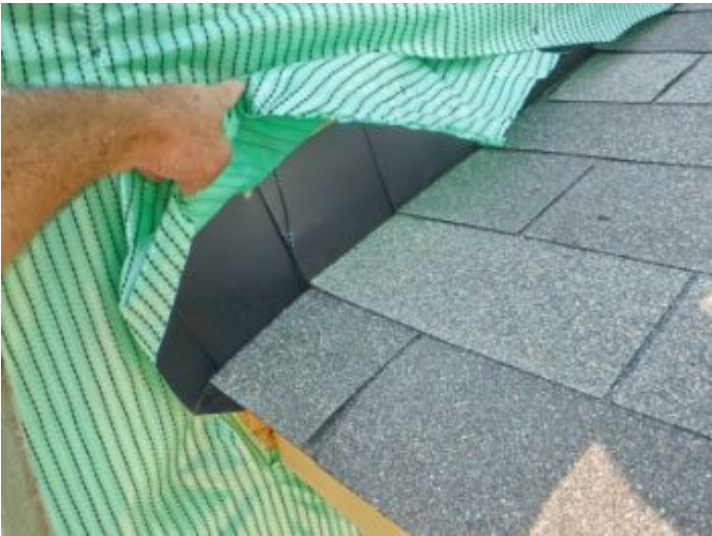
- **Drip Edge** Missing- We noted that the metal **drip edge** was not installed on the home at inspection time. **Drip edge** is typically installed before the roof covering and has been required since the adaptation of the 2012 IRC. Though it can be installed after the shingles it is more difficult to do it correctly. Proper method as specified in the 2012 IRC is under the underlayment at eaves and over the underlayment at gables while extending 2 inches minimum on top of the roof deck. Recommendation is to have it installed.

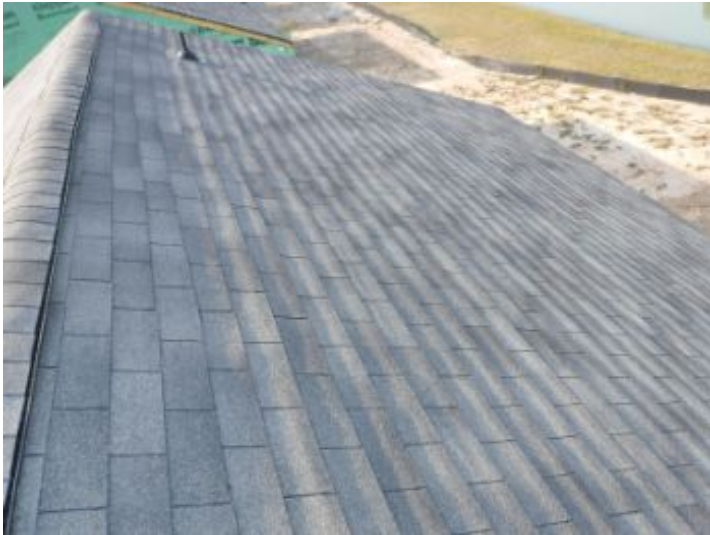
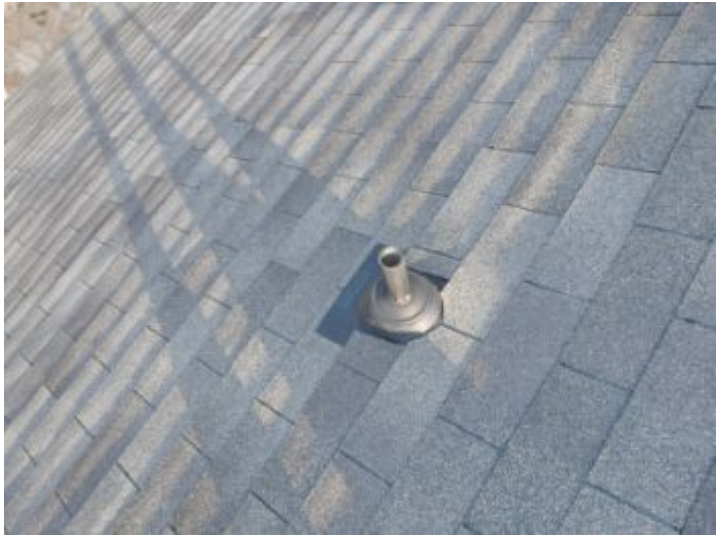
Drip Edge Missing- We noted that the metal drip edge was not installed on the home at inspection time. Drip edge is typically installed before the roof covering and has been required since the adaptation of the 2012 IRC. Though it can be installed after the shingles it is more difficult to do it correctly. Proper method as specified in the 2012 IRC is under the underlayment at eaves and over the underlayment at gables while extending 2 inches minimum on top of the roof deck. Recommendation is to have it installed.
